Tributary 4 Watershed Study for the Town of Cheverly

Introduction

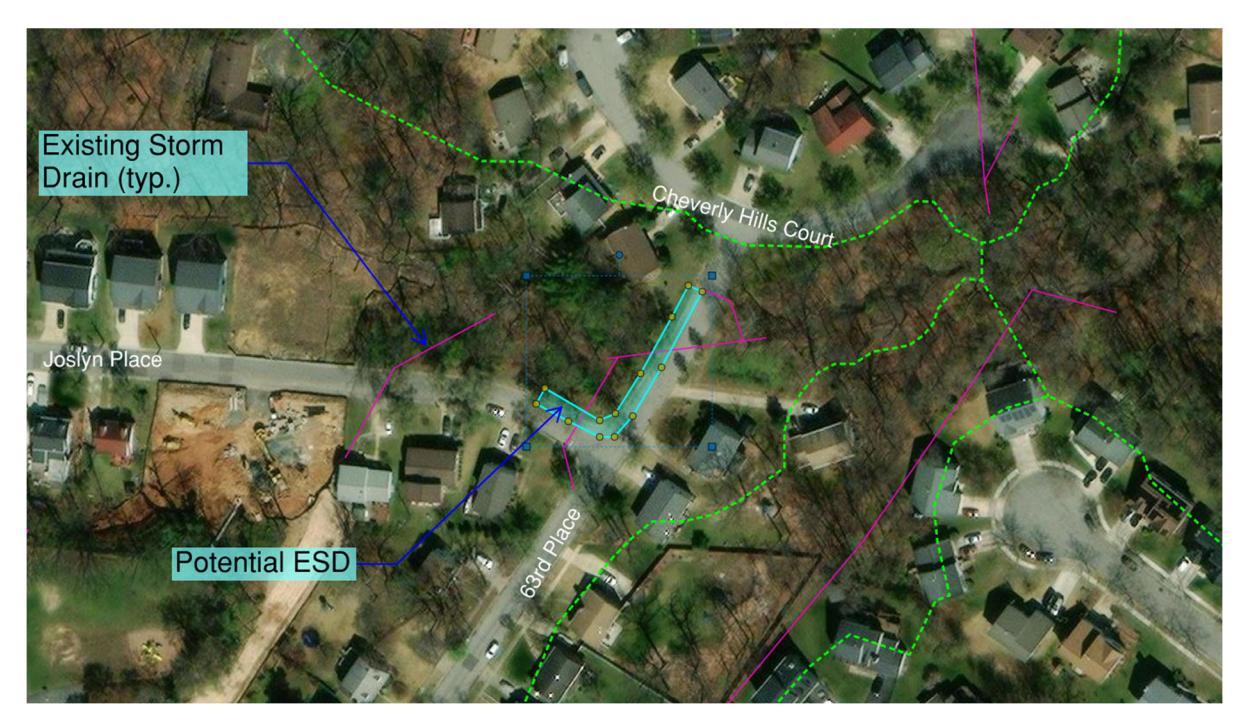
Area A is a relatively flat area located along the west side of 63rd Place between Cheverly Hills Court and Joslyn Place (*Map 4. Area A Map*). This area currently has volunteers removing invasive vegetation which has taken root. They are removing the invasive vegetation and replacing it with native trees and grasses. Thirty trees have already been planted and the community volunteers plan to plant more. They are also planning to remove Bradford Pears growing in this area. The roads are 25 feet wide and the inlet on 63rd Place is 150-feet from the corner of the intersection of 63rd Place and Joslyn Place. The drainage area to the inlet on 63rd Place appears to exceed 1-acre which is greater than most ESD practices should receive. However, by utilizing multiple cells and establishing a treatment train of micro-bioretention areas starting along Joslyn Place and continuing around the corner on 63rd Place, this runoff could be treated. Installing a check dam or weir would be required to separate the cells.

The first cell should be a plunge pool to dissipate the velocities from the curb and gutter. An underdrain system would be required due to the soil classification. Some of the roadway could be removed since there are no houses on the north side of Joslyn Place and the west side of 63rd Place. This would reduce the available street parking, but these practices could additionally act as bump outs for traffic calming. The existing inlet on 63rd Place could be used either as a control structure or a connection point for the underdrain system that would be installed. The largest potential issues in this area include potential underground utility conflicts, costs for concrete curb removal and replacement, and the loss of parking spaces. Further exploration of this practice would need to evaluate the existing utilities in the vicinity, evaluate the turning radii of vehicles that would use this intersection (bus, trash truck, etc.), soil borings, verification of property lines and delineation of the drainage area coming to the inlet and potential practice.

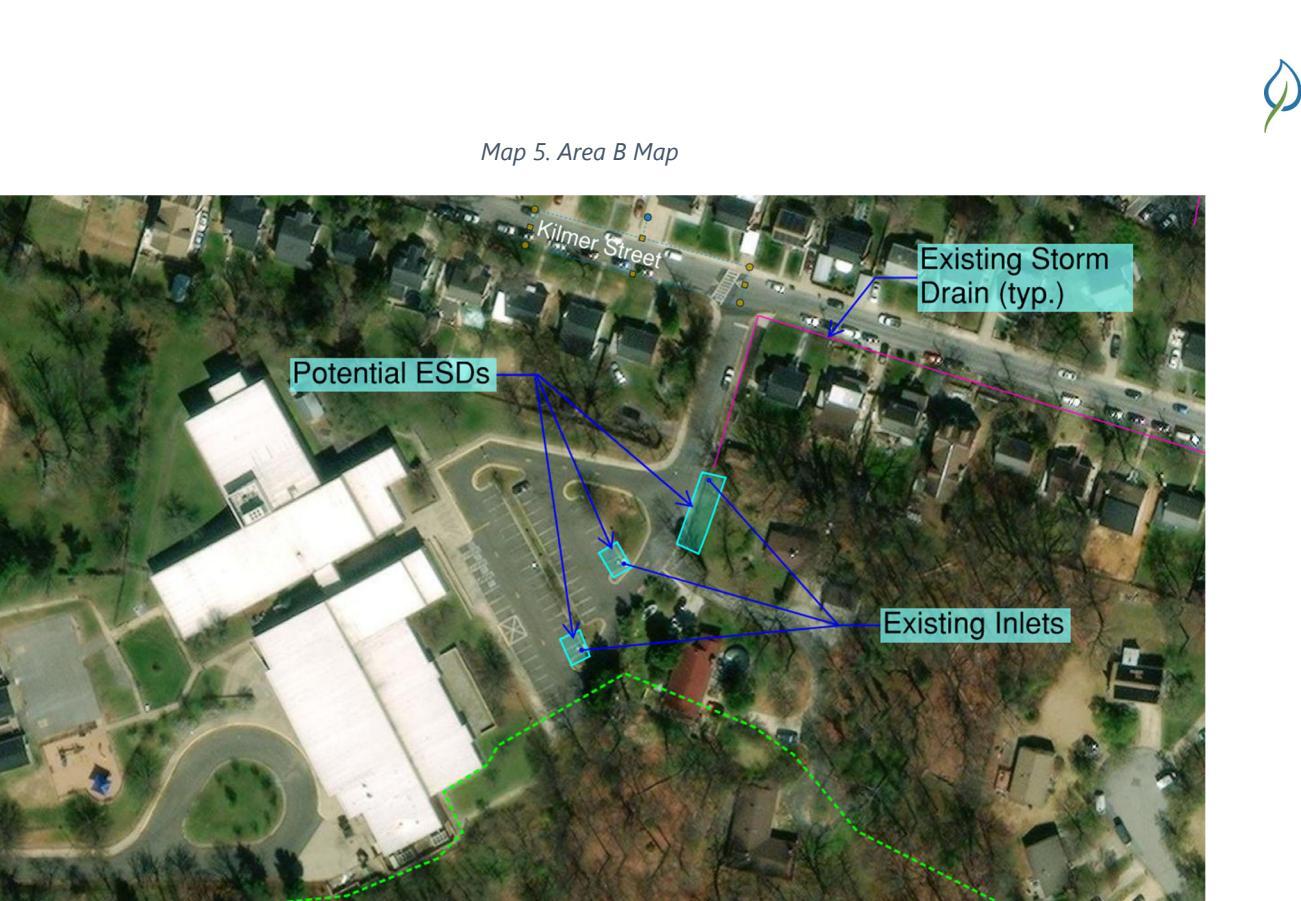
Area B is located within the parking lot of Gladys Noon Spellman Elementary School (*Map 5. Area B Map*). As stated previously, this parking lot is tiered into the slope with a driveway connecting to Kilmer Street. The parking lot has two inlets located in the corners of two parking spots and one inlet on the eastern side of the driveway connecting the parking lot to Kilmer Street. This area has potential for three micro-bioretention areas with an underdrain that connects to the existing inlet. The existing inlets could also be used as a control structure for the practices.

Although the inlets in the parking spaces are deep enough to allow for a micro-bioretention practice, they would require the loss of at least two parking spaces per inlet which may not be favorable to the school. The inlet in the driveway does not impact parking and could be used as an overflow for a micro-bioretention practice that receives about 8,000 SF of impervious area. The practice that could be installed in this area would need to have more than one cell with a check dam or weir between the cells. Additionally, some impervious areas of the driveway would need to be removed for this practice to be installed. Further exploration of this practice would need to evaluate the turning radius of vehicles using the driveway, soil borings, verification of the property lines, and delineation of the drainage area coming to the inlet and potential practice.

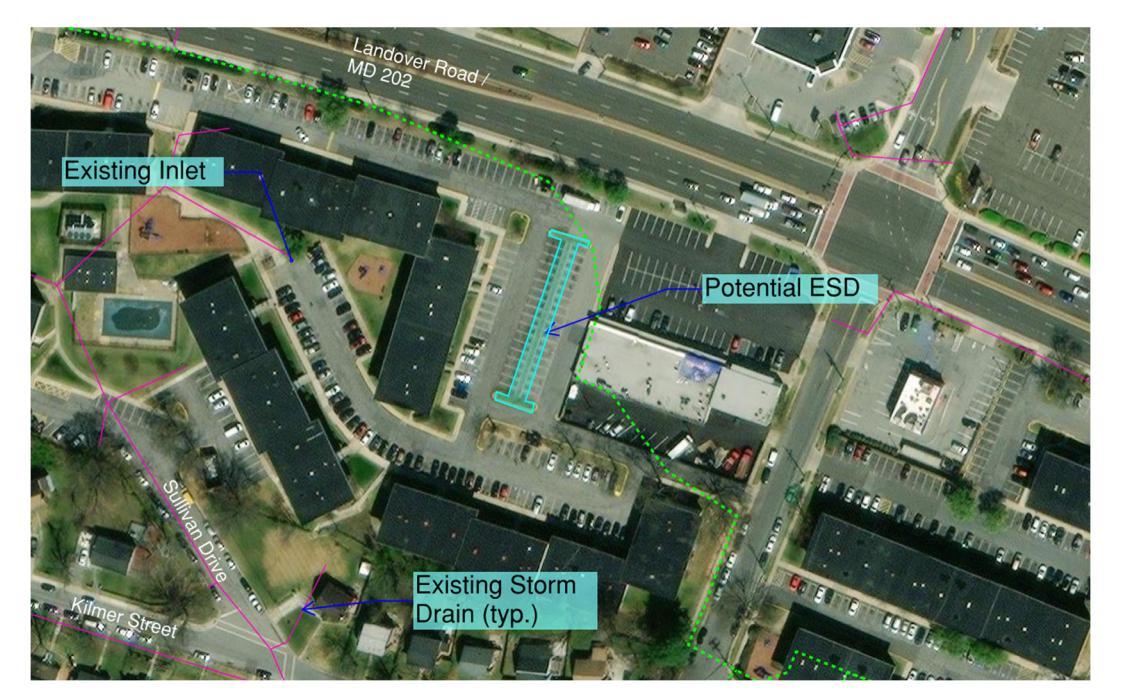
Area C is in the easternmost parking lot for The Benjamin at Landover Hills Apartments (*Map 6. Area C Map*). The parking lot has two 20-foot travel lanes around the two rows of parking spots in this area with a six-foot impervious median in between. The median could be removed and replaced with a micro-bioretention area. If the travel lanes were reduced to 15 feet and made one way, the footprint of the micro-bioretention area could be increased. To direct runoff into the practice, asphalt speed humps could be installed.

The major drawback to this potential practice is that there is not an existing storm drain inlet close to this area. The nearest inlet is approximately 350 linear feet away. Without anywhere to connect an underdrain from this practice, this area may not be feasible to retrofit. Further exploration of this practice would need to establish communication with the property owner, evaluate the existing utilities in the vicinity, evaluate the turning radius of the vehicles using the parking lot, verification of the property lines, soil borings, delineation of the drainage area coming to the potential practice, and determine if extending the storm drain system is viable.

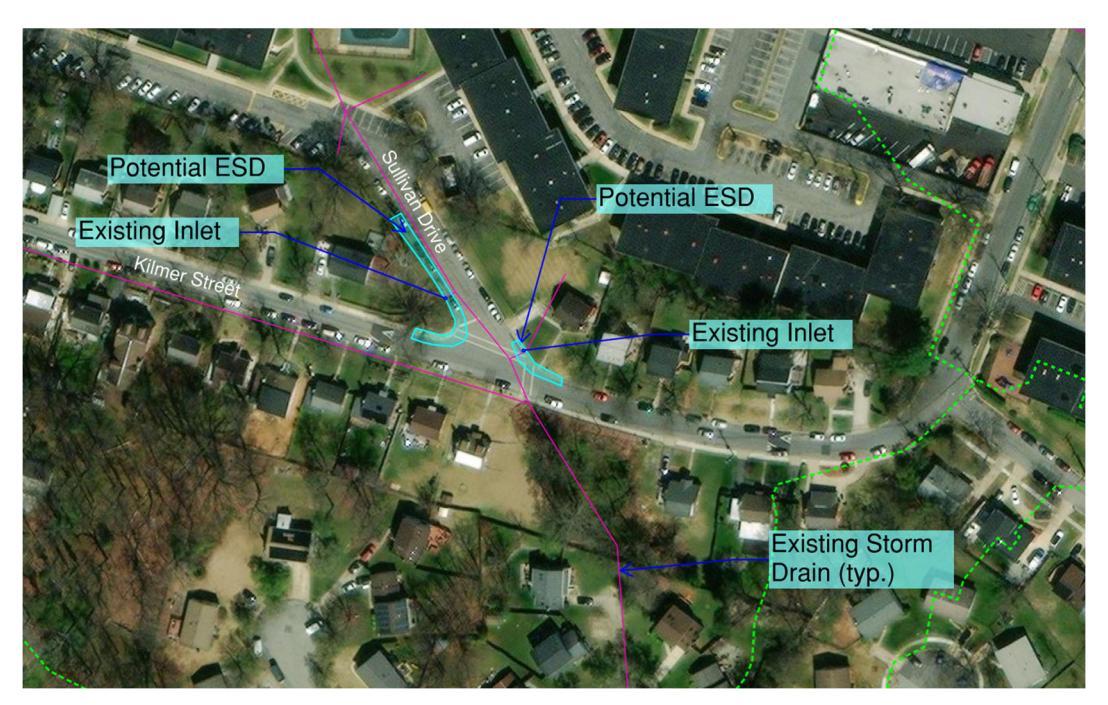
Area D is located at the intersection of Sullivan Drive and Kilmer Street (*Map 7. Area D Map*). The existing storm drain system has an inlet located on both sides of Kilmer Street. Given that this area is the lowest point of the roads within the area, runoff from both Sullivan Drive and Kilmer Street is collected into the storm drain system here. This intersection is at an angle which creates a crosswalk that is 80 feet long and Kilmer Street is only 34-feet wide. The crosswalk length could be reduced by installing a streetscape micro-bioretention area that could provide shelter to pedestrians, reduce the length of the crosswalk, and provide treatment for runoff. The existing inlets could be used as control structures for larger-than-designed storms. The drainage area for both inlets exceed 1-acre and a treatment train of micro-bioretention cells would need to be implemented. As with the practice outlined in Area A, these practices should have a plunge pool in the first cell to dissipate the runoff velocity entering the practices.

The major concerns for these practices would include existing utility impacts, loss of parking, and the potential for the practices to be undersized for the drainage area. Further exploration of this practice would need to evaluate the turning radius of vehicles using this intersection, soil borings, delineation of the drainage area coming to the inlets and the potential practices, coordination with property owners, and verification of the property lines.

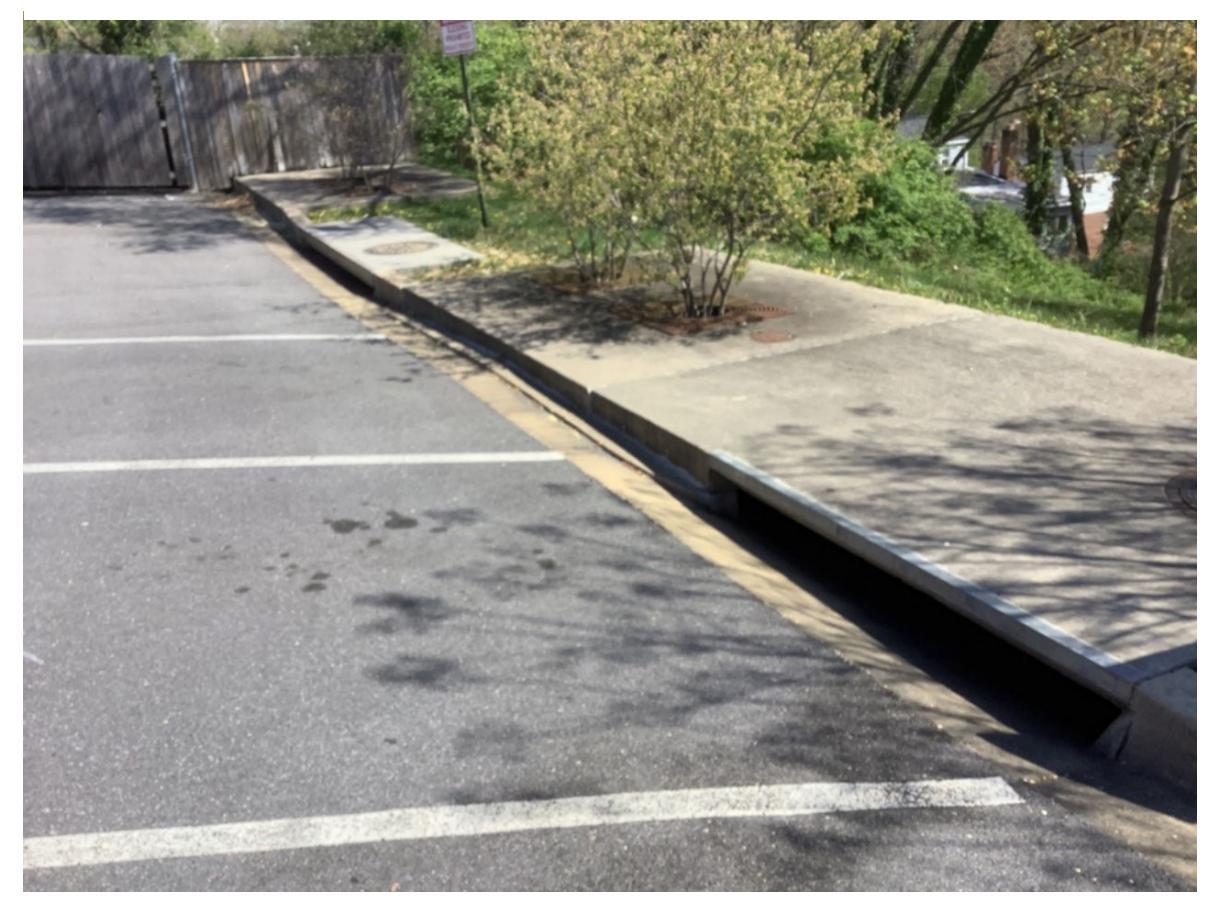
T1 receives runoff from the eastern portion of the drainage area and accounts for 19.89 acres of the overall drainage area. The roads that contribute to the runoff in this storm drain system include Joslyn Place, Jason Street and 63rd Place. The contributing impervious areas in T1 include the roads and St. Ambrose Church and St. Ambrose School. St. Ambrose has a large parking lot and two stormwater structures for the church and the school. The Clean Water Partnership was involved with the installation of the two Filterras that treat runoff from the parking lot between the church and school. These two practices have a combined drainage area of 0.94 Acres with approximately 0.70 acres of impervious area. Since these practices already exist, the study's focus shifted to other areas (*Appendix C, Photo 1*).

Tributary 1 (T1) Outfall 1 Outfall 2 Photo 1 Filterras in Church Parking Lot, Tributary 1 (Existing practice present)

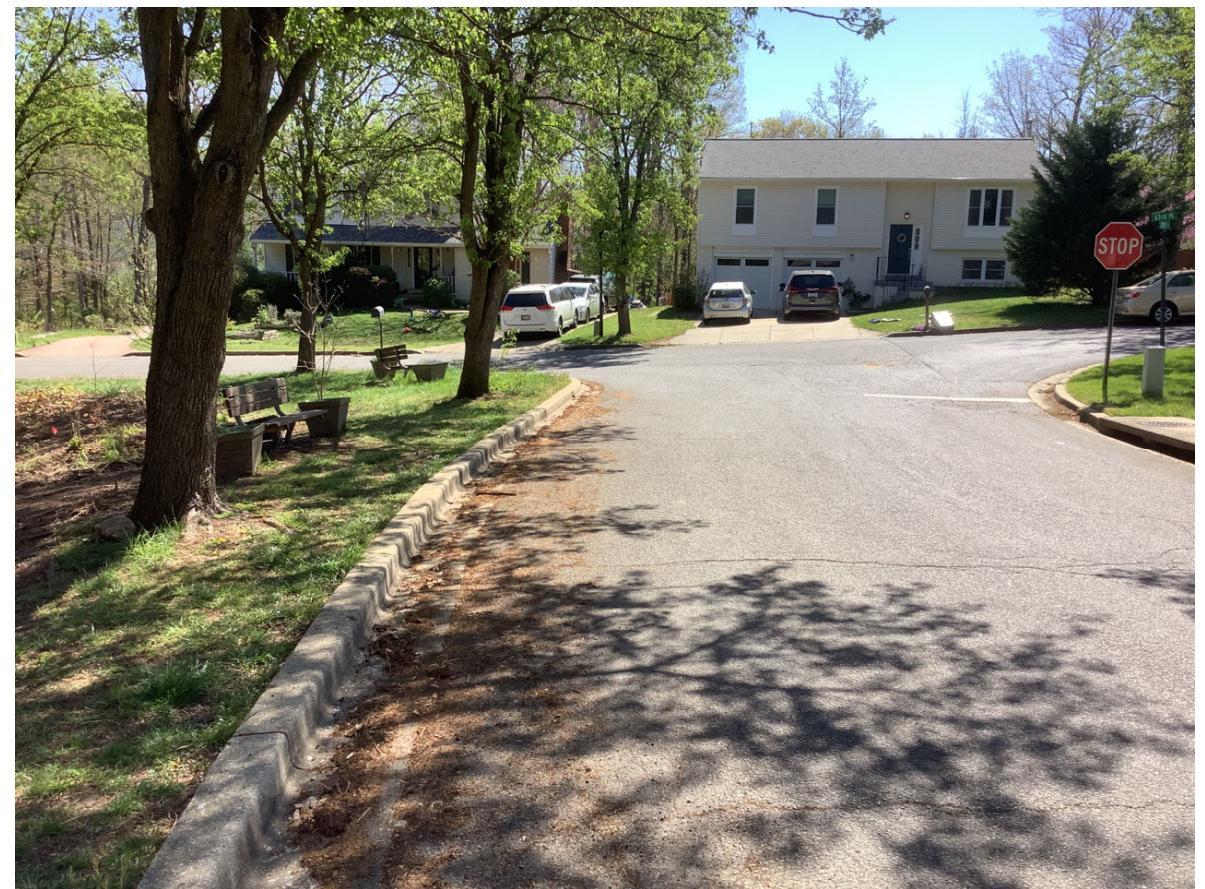
The majority of the roads in this subdrainage area have steep slopes associated with them which make it difficult to install practices within the Town's right-of-way. There is one area where the roads flatten out near the intersection of 63rd Place and Joslyn Place that was evaluated as a potential project location (*Appendix C, Photo 2*).

Photo 2. Joslyn Place looking towards 63rd Place, Area A – Tributary 1

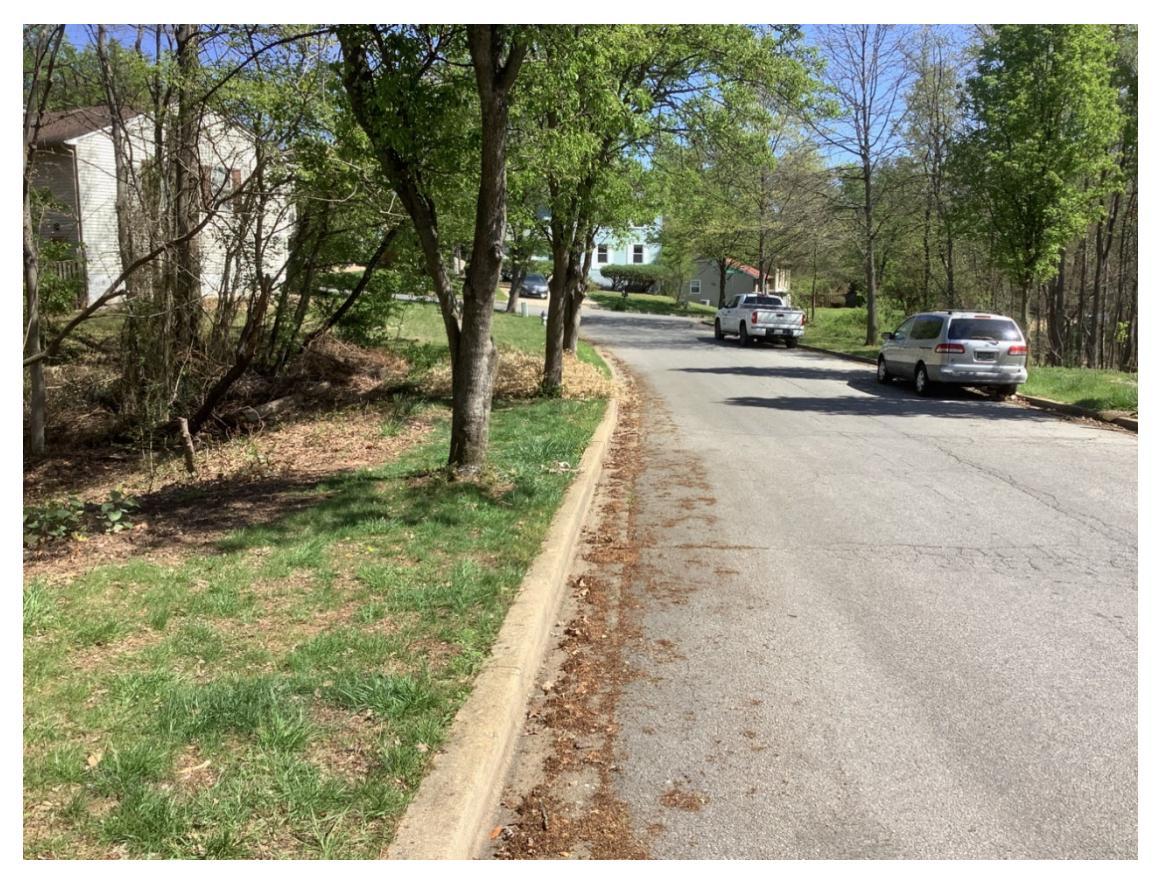
On 63rd Place between Cheverly Hills Court and Joslyn Place, the generally steep road has an area where it levels out. According to the property owners in the area, the community has recently cleared invasive vegetation from the area and planted 30 trees with the intention to plant more. There are also some Bradford Pear Trees in this area that the community intends to remove. Both 63rd Place and Joslyn Place are approximately 25 feet wide with houses constructed on only one side of the road. This area will be called *Area A* in the Potential Opportunities section of the study (*Appendix C, Photos 3, 4, and 5*).

Photo 3. 63rd Place looking towards Cheverly Hills Court, Area A – Tributary 1

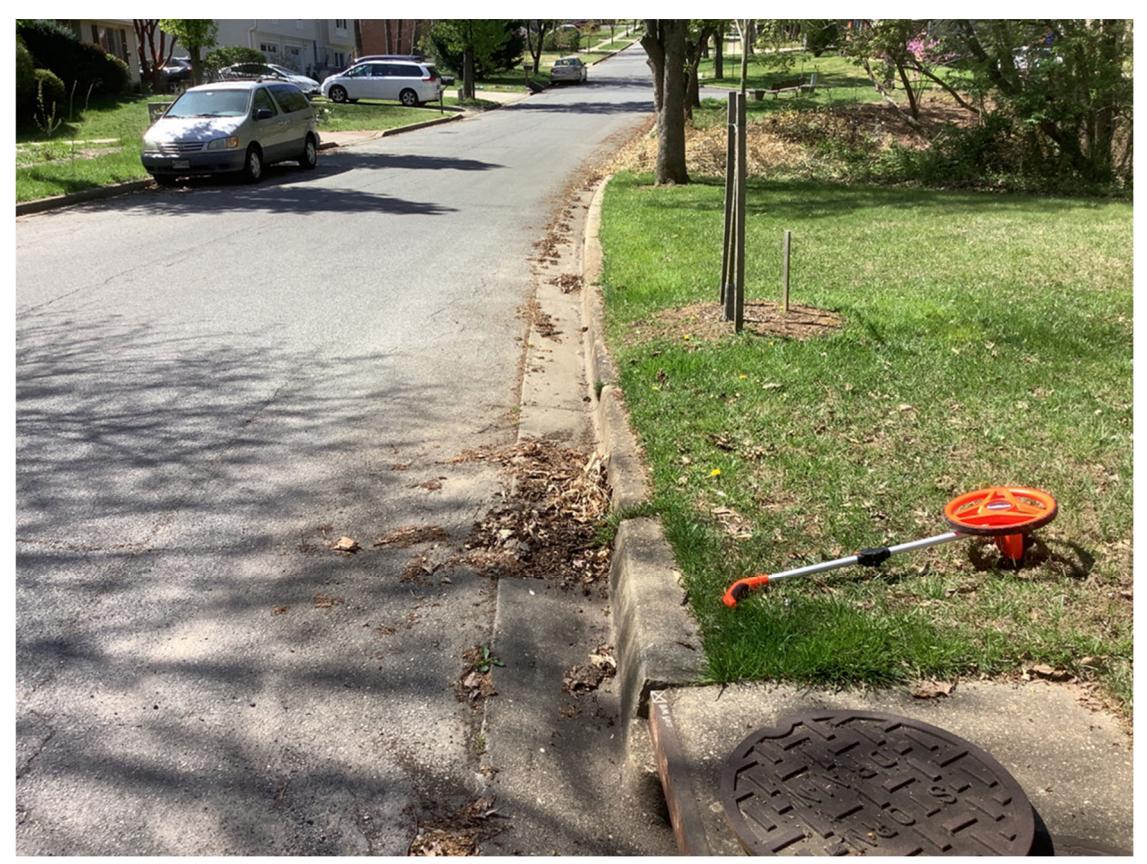
Photo 4. Inlet on 63rd Place looking towards Joslyn Place, Area A – Tributary 1

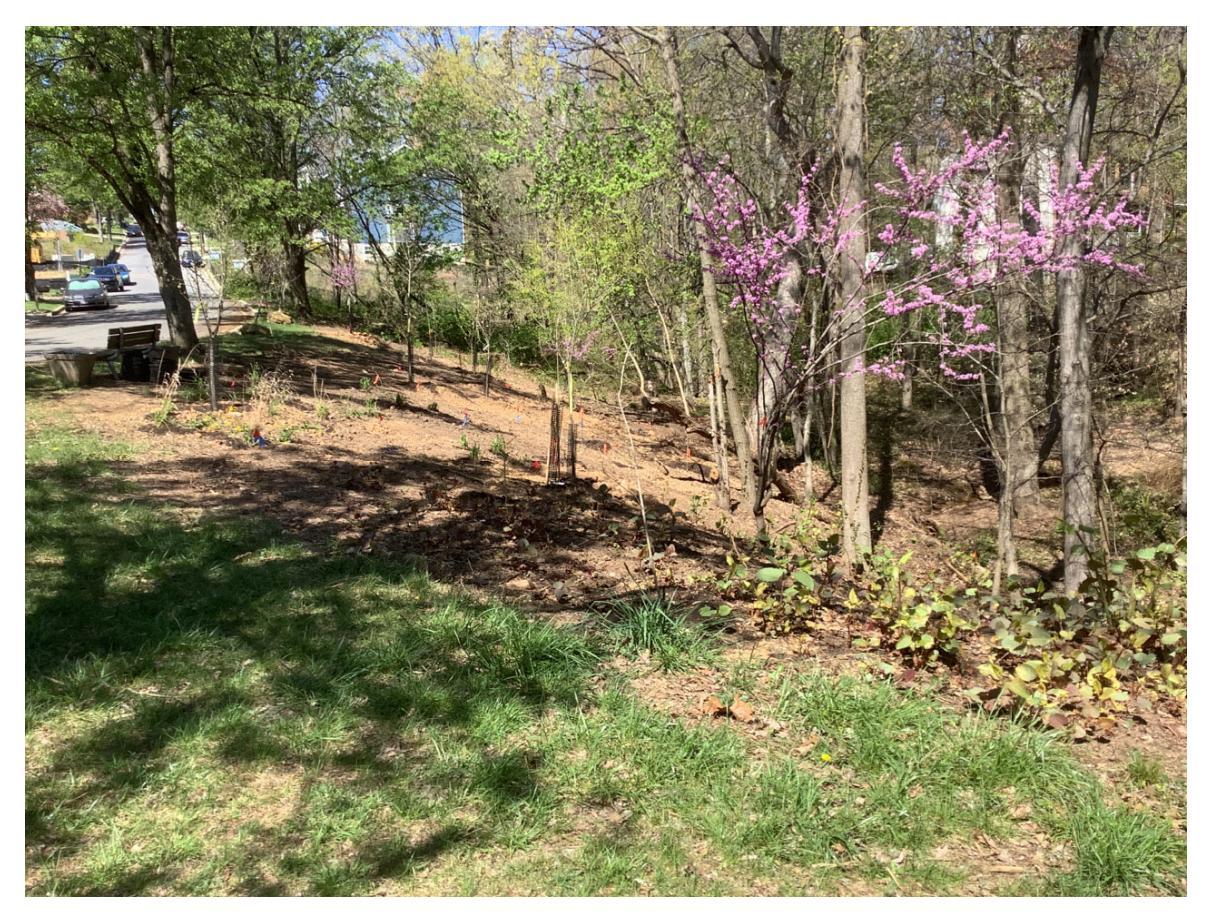
Photo 5. Invasive Removal done by Community near Area A – Tributary 1

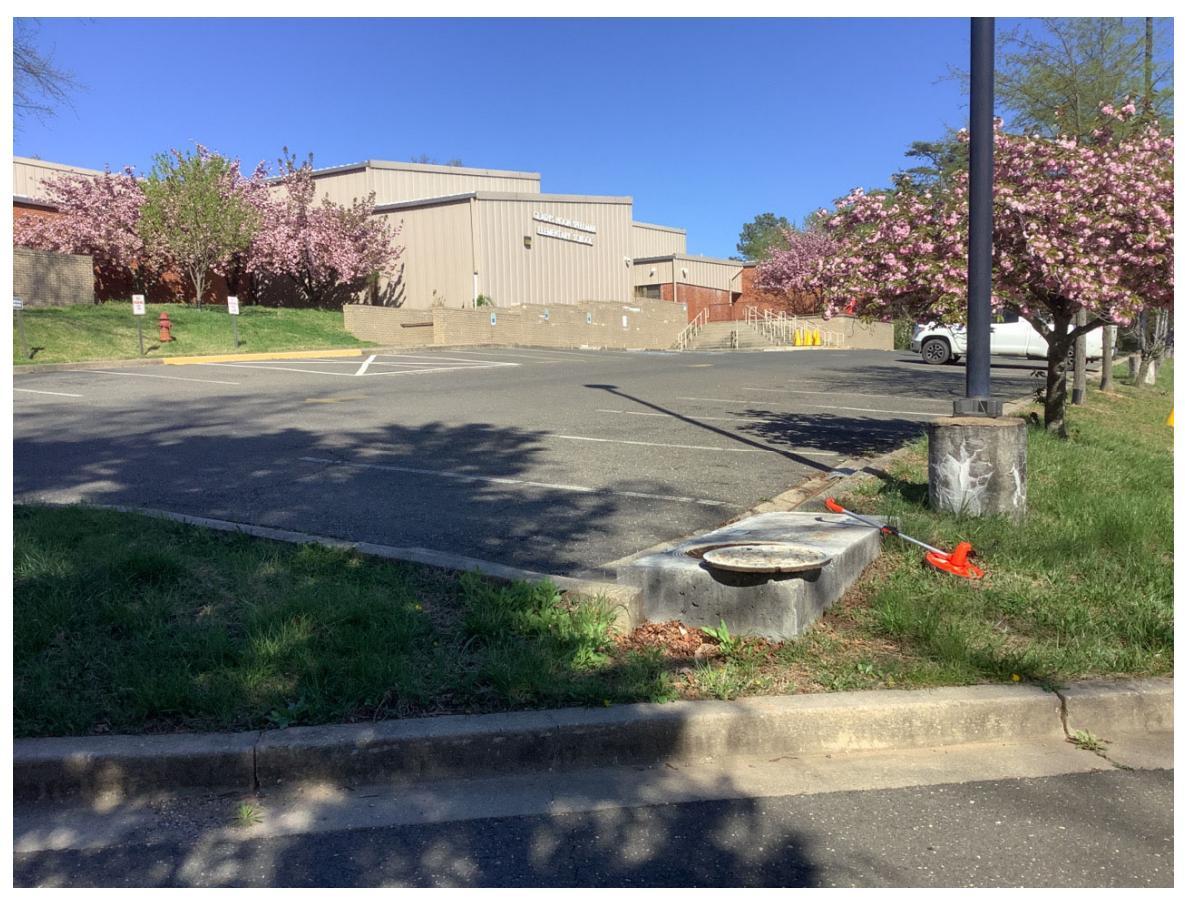
Gladys Noon Spellman Elementary School has a large parking lot on the east side of the property. The parking lot is graded into the slope with benches for the parking spaces and travel lanes (*Appendix C, Photos 6 and 7*). The existing storm drain system has an inlet in the corner of each bench and an inlet along the driveway entrance (*Appendix C, Photos 8 and 9*). Since this area has existing inlets and is comprised of mostly impervious surfaces, it provides an opportunity for ESD practices to be installed. This area will be called *Area B* in the Potential Opportunities section of the study.

Photo 6. Gladys Noon Spellman Elementary School Upper Parking Lot Inlet, Area B - Outfall 1

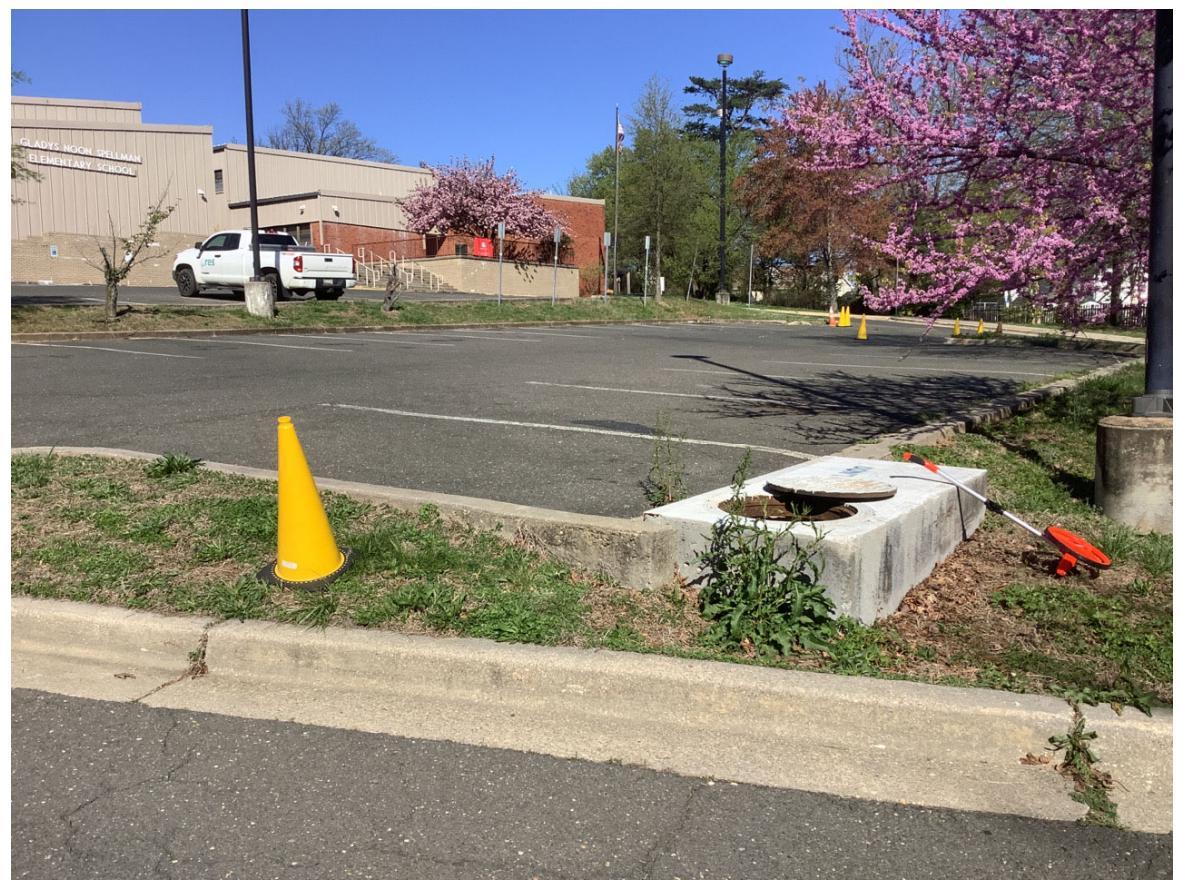
Photo 7. Gladys Noon Spellman Elementary School Lower Parking Lot Inlet, Area B - Outfall 1

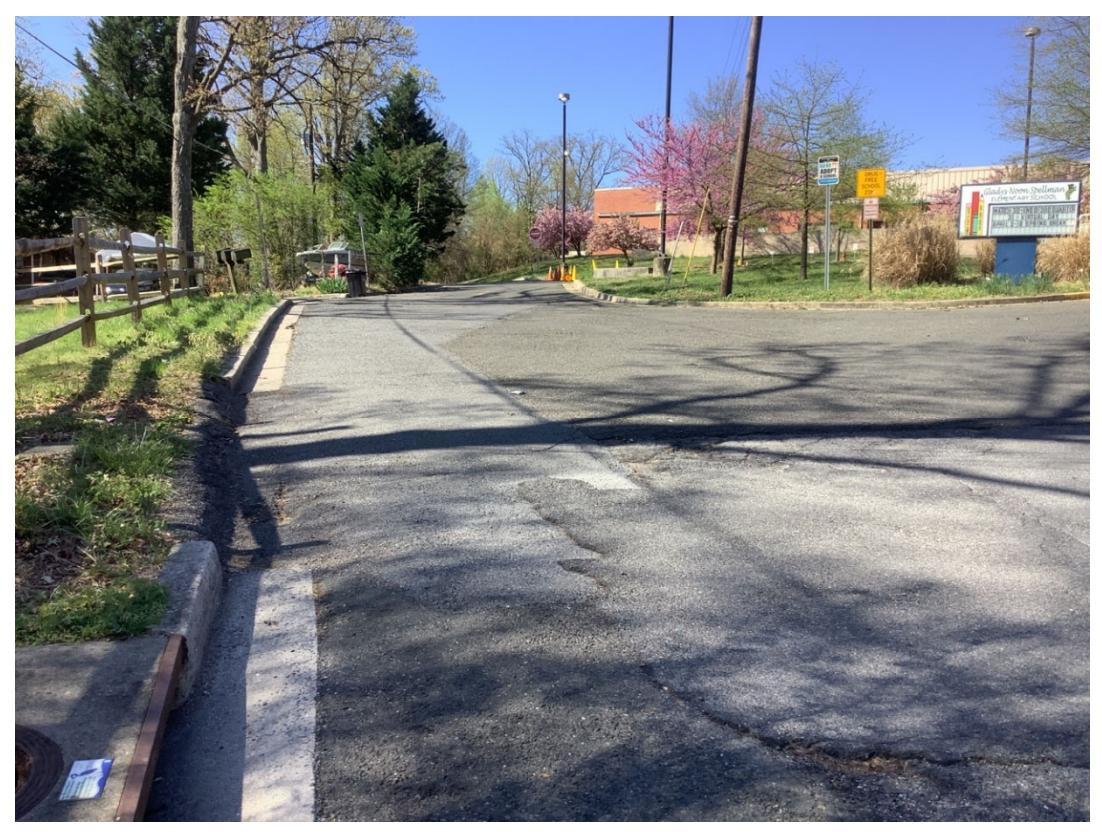
Photo 8. Gladys Noon Spellman Elementary School Driveway to Parking Lot Inlet, Area B - Outfall 1

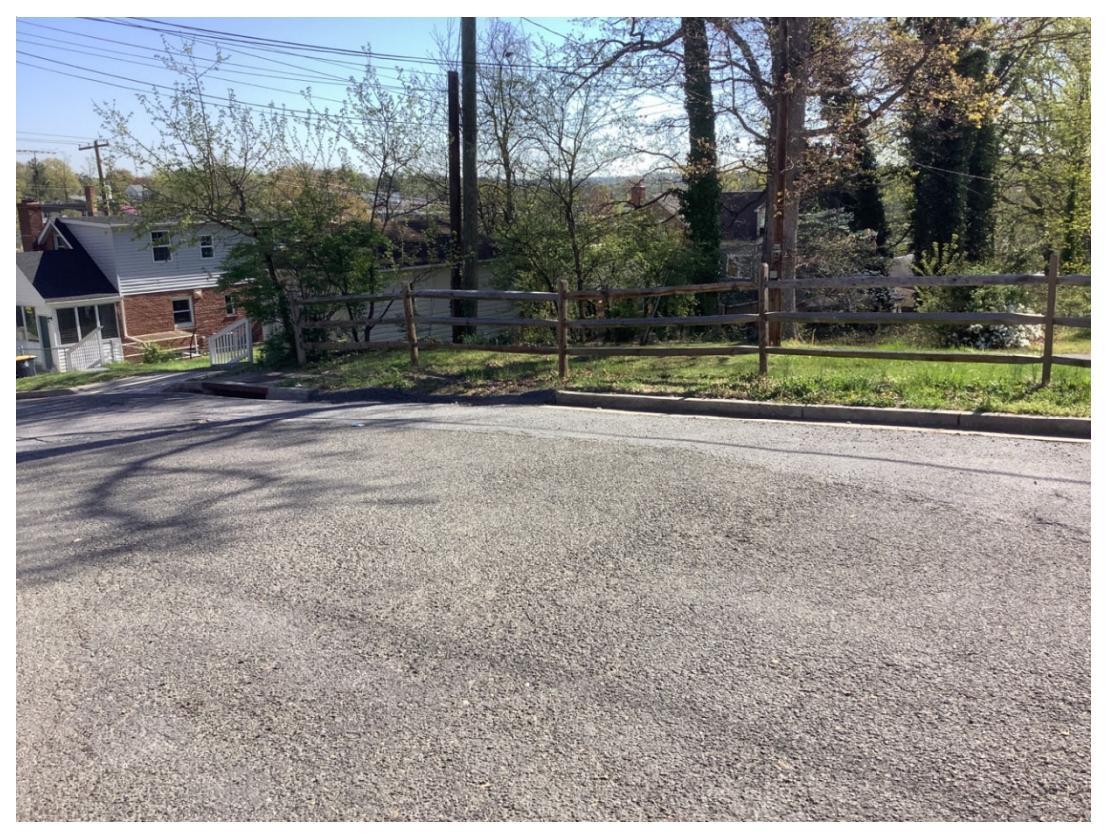
Photo 9. Gladys Noon Spellman Elementary School Upper Parking Lot Inlet, Area B - Outfall 1

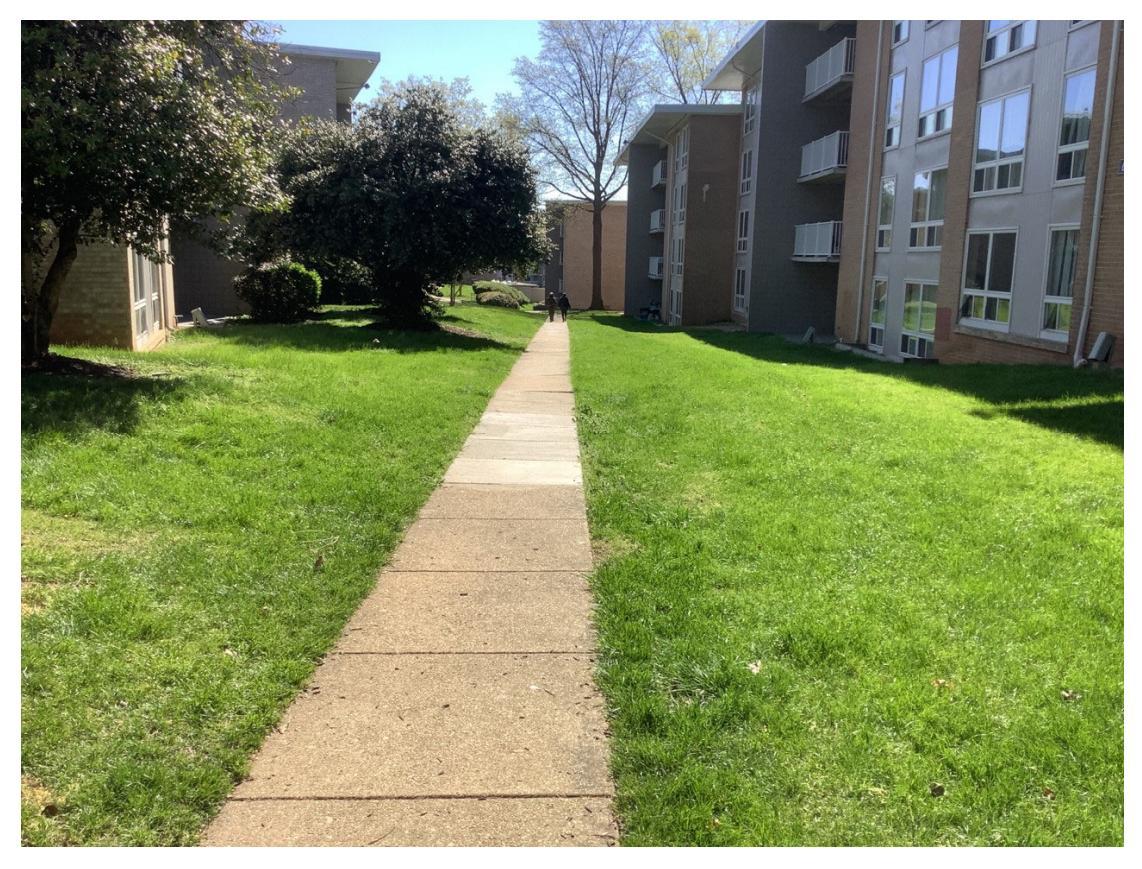
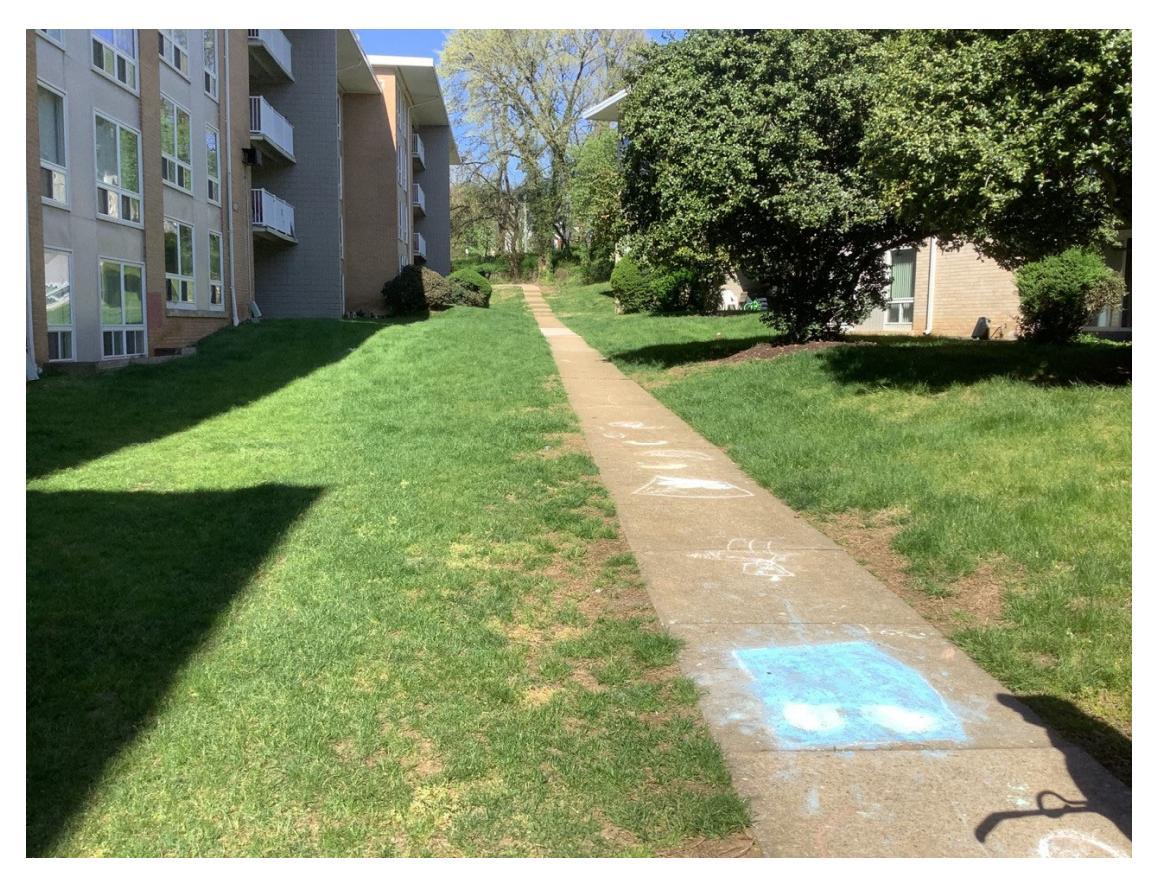
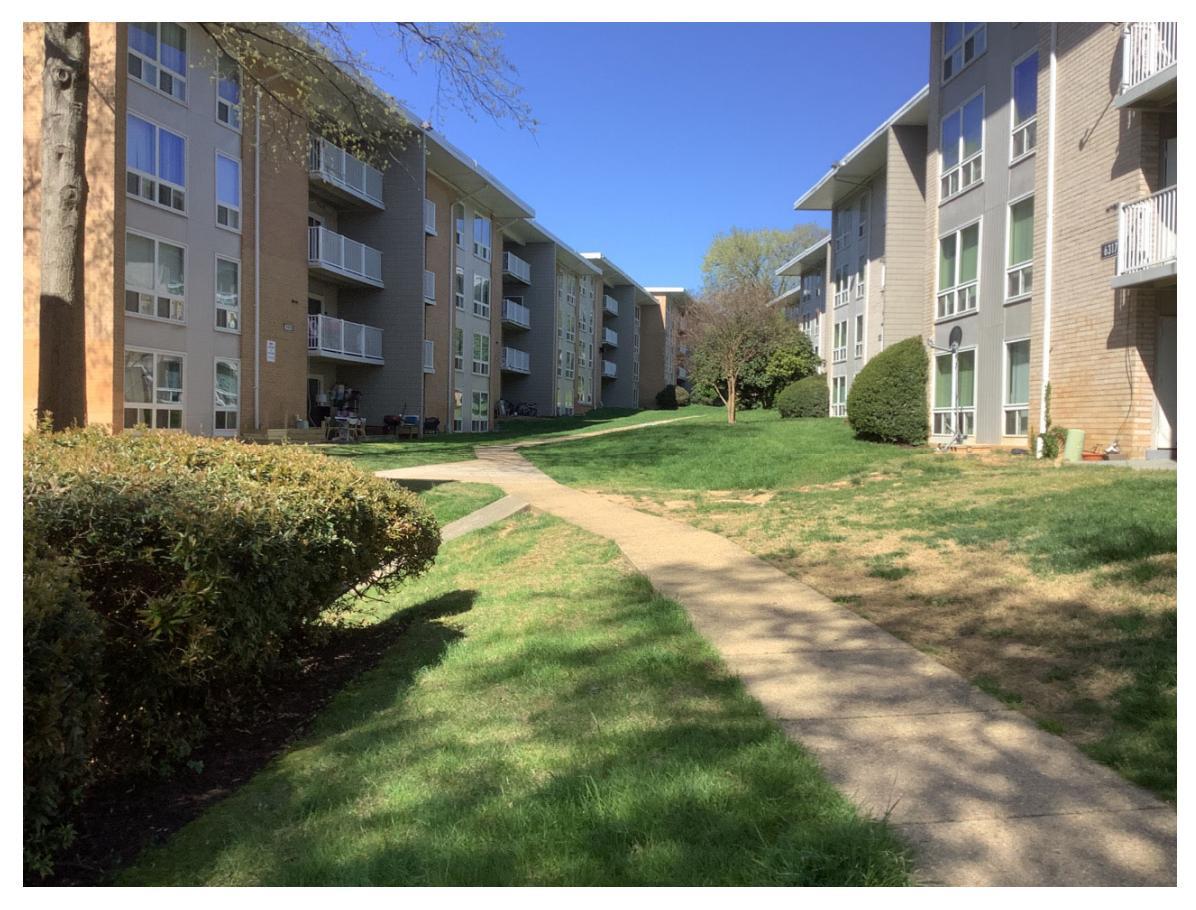
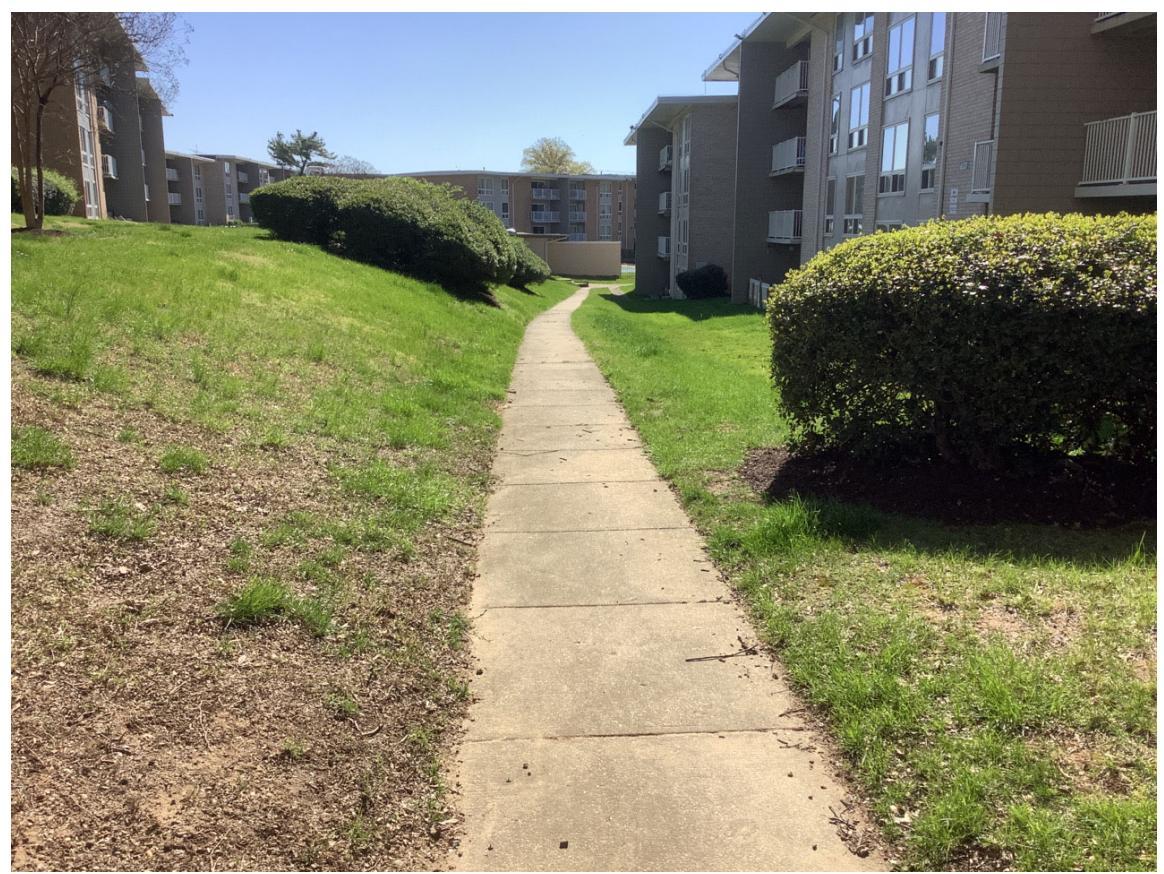
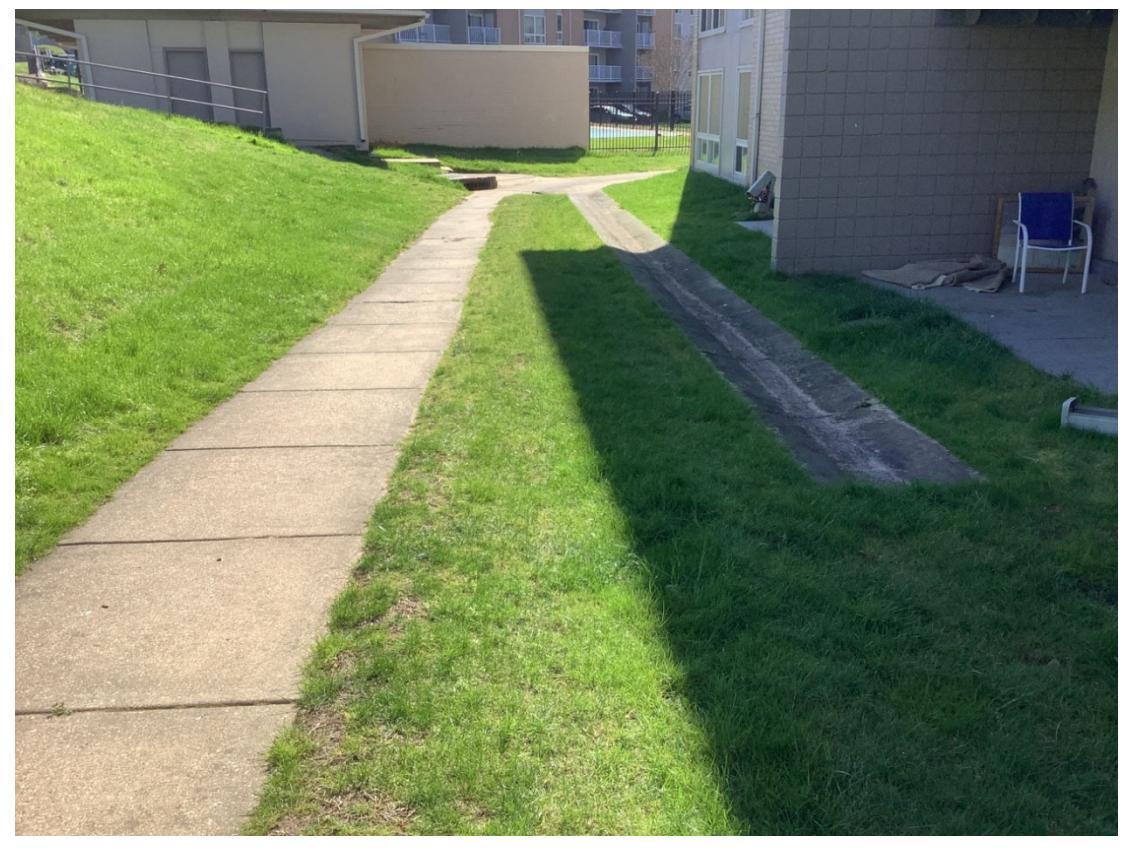
The Benjamin at Landover Hills Apartments has seven buildings and three large parking lots. The storm drain system runs through the middle of this parcel and between the buildings (*Appendix C, Photos 10, 11, 12, 13, and 14*). Several factors limit the installation of an ESD practice in this area including spacing and topography between the apartment buildings, the storm drain line is not wide enough to include a micro-bioretention area, nor is it at a grade where a bio-swale could be beneficial. A bio-swale was considered but grading for this practice would be difficult to tie the proposed contours into the existing grade on the side slope. This grading would require more excavation and disturbance. Given the topography in this area, if a larger-than-designed storm occurs, the runoff from the bio-swale could cause flooding of both the sidewalk and apartments located on the first floor. Additionally, since the storm drain is located above-grade from the potential swale, if there were any maintenance to the storm drain, the bio-swale would be directly impacted and undesirable for the ESD.

Photo 10. The Benjamin at Landover Hills Apartments, Area between Buildings, Outfall 1
