Tributary 4 Watershed Study for the Town of Cheverly

Introduction

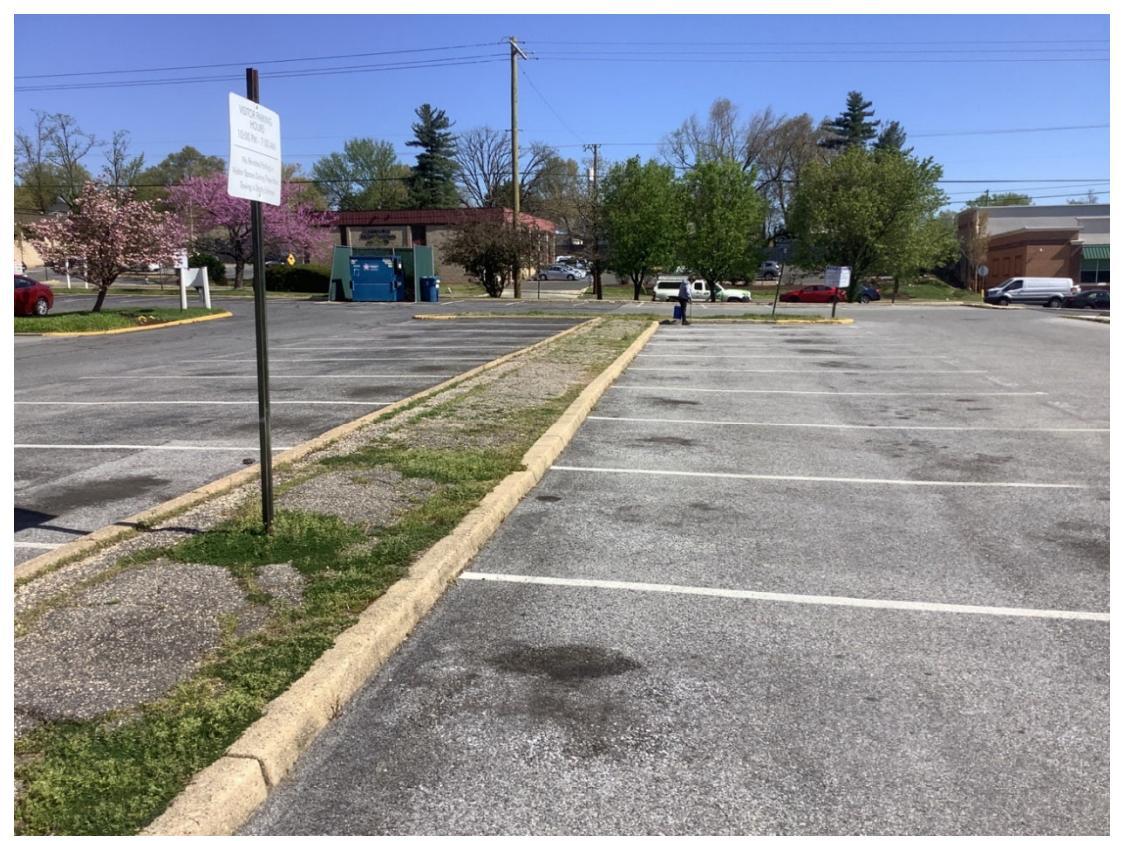
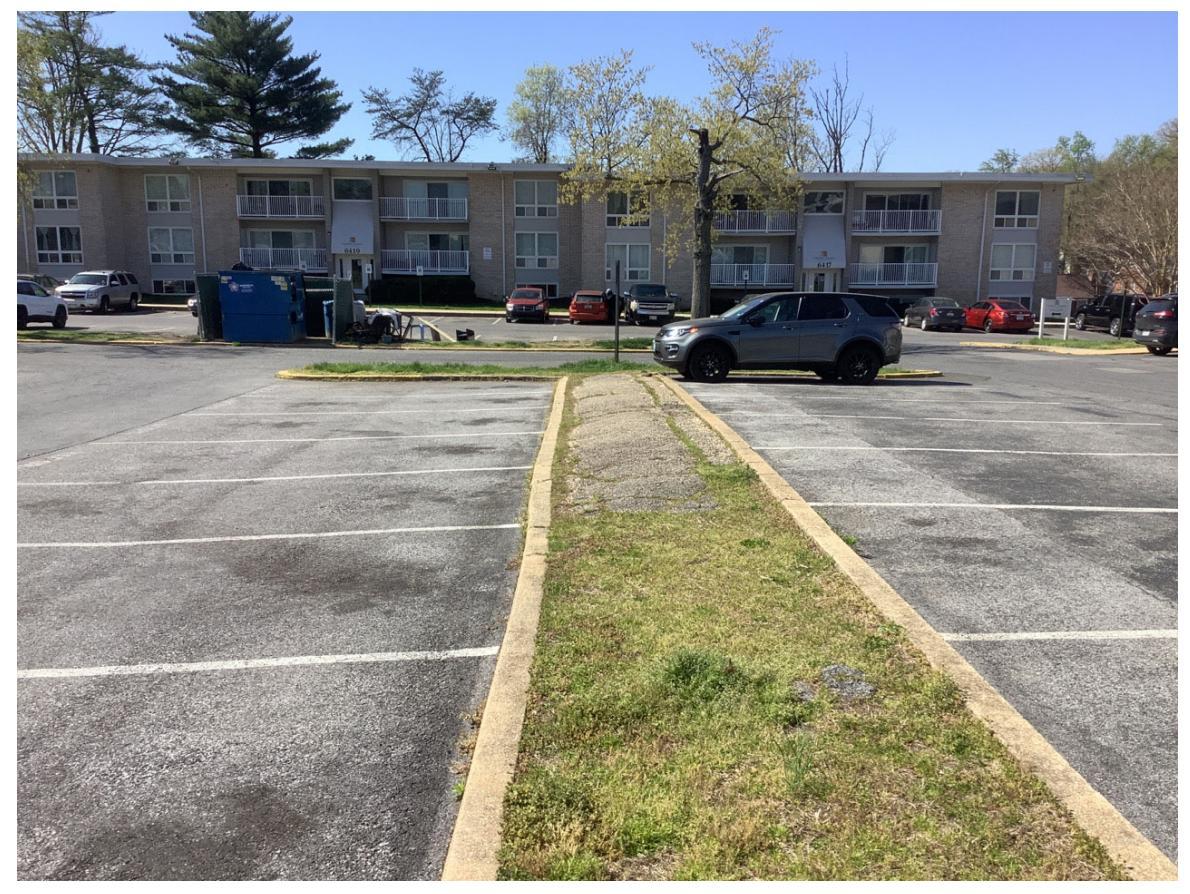
The parking lot on the eastern side of the apartment complex has the potential to accommodate a micro-bioretention area (*Appendix C, Photos 15 and 16*). The area has a narrow island between two rows of parking. This island could be expanded and the travel lanes behind the parking spots could be changed from two-way to one-way with asphalt speed humps to help direct runoff into the practice. The major downside to this area is that the closest inlet to which this area currently drains is approximately 350 linear feet away which means there is no place for the underdrain to connect to an existing inlet or manhole. This area will be called *Area C* in the Potential Opportunities section of the study.

Photo 15. The Benjamin at Landover Hills Apartments Easternmost Parking Lot, Outfall 1 - Area C

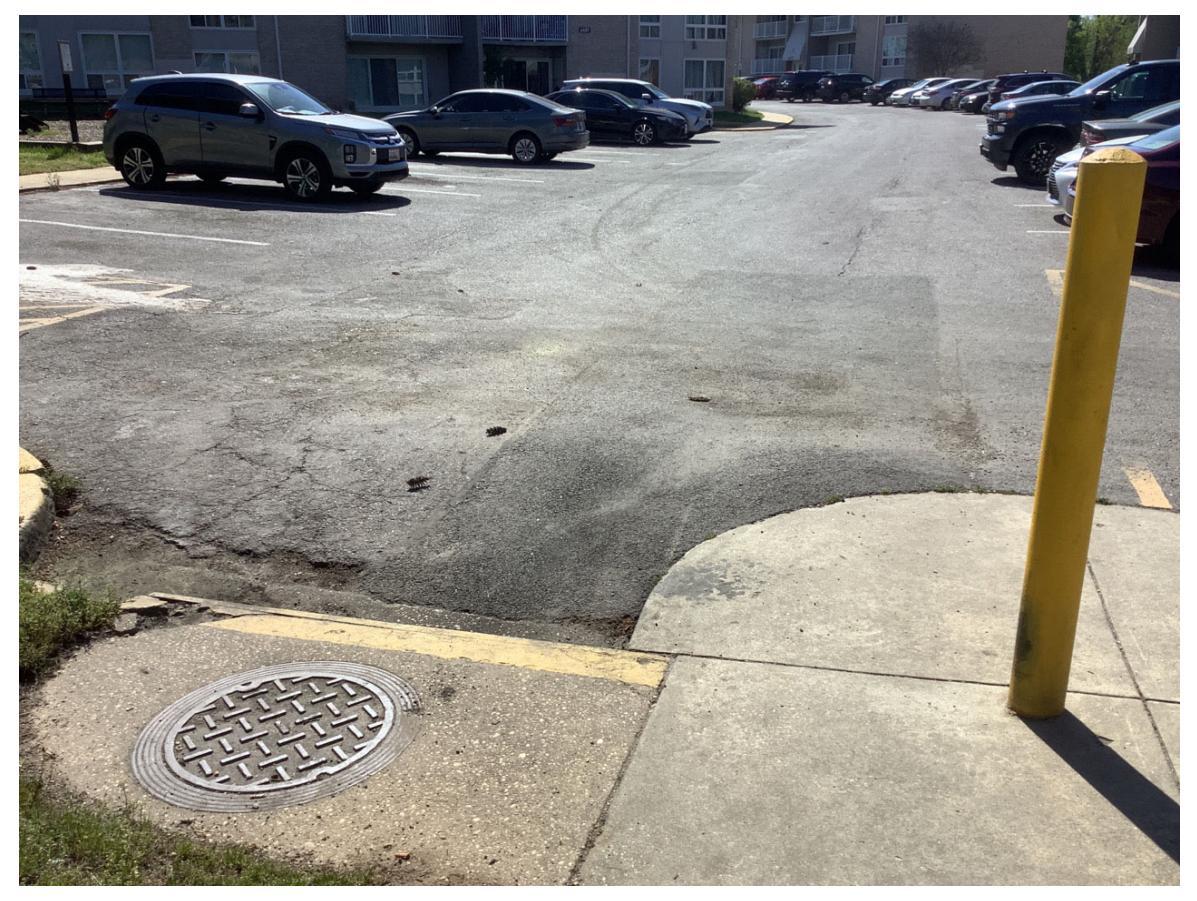
Photo 17. The Benjamin at Landover Hills Apartments Inlet for Area C, Outfall 1

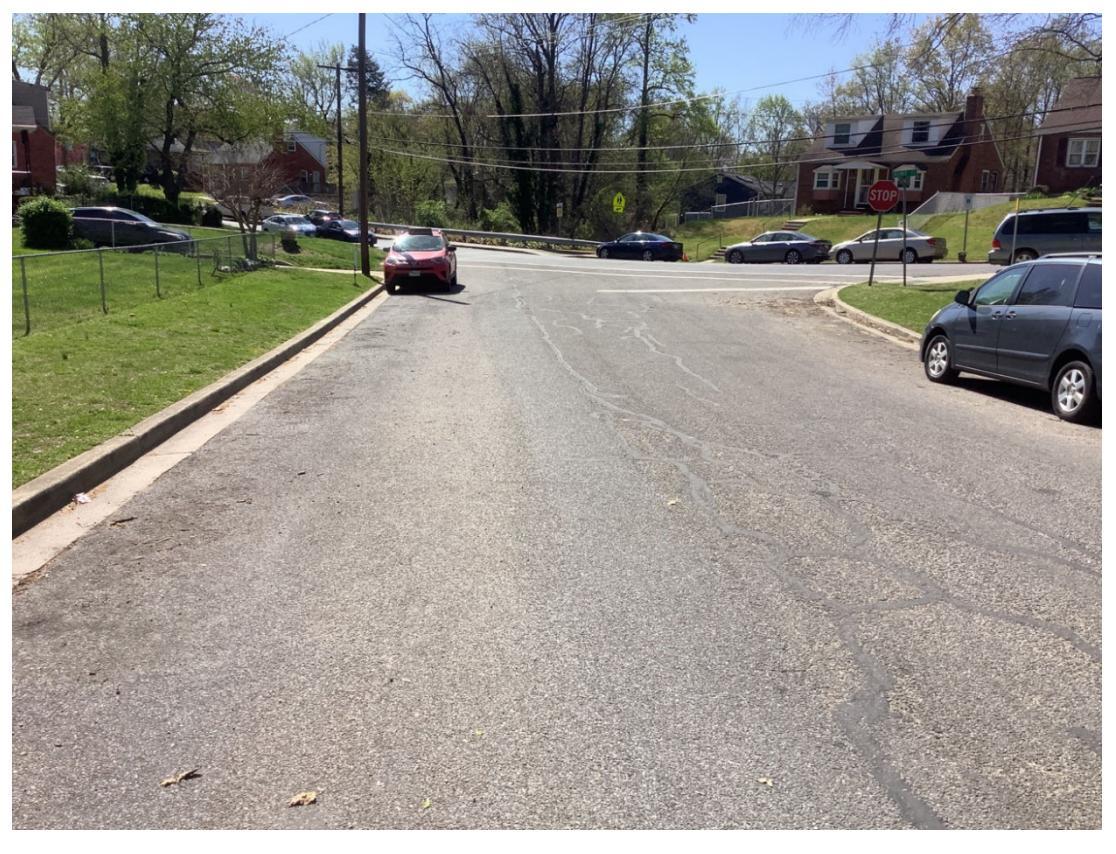
Sullivan Drive is located on the south side of the apartment complex and connects 63rd Place and Kilmer Street (*Appendix C*, *Photo 18*). This road has several inlets that connect to the storm drain system near the intersection with Kilmer Street (*Appendix C*, *Photos 19 and 20*). This intersection has a crosswalk that is approximately 80 feet long and is located in the lowest point of Kilmer Street within this subdrainage area. This area will be called *Area D* in the Potential Opportunities section of the study.

Photo 18. Sullivan Drive looking towards Kilmer Street, Outfall 1 - Area D

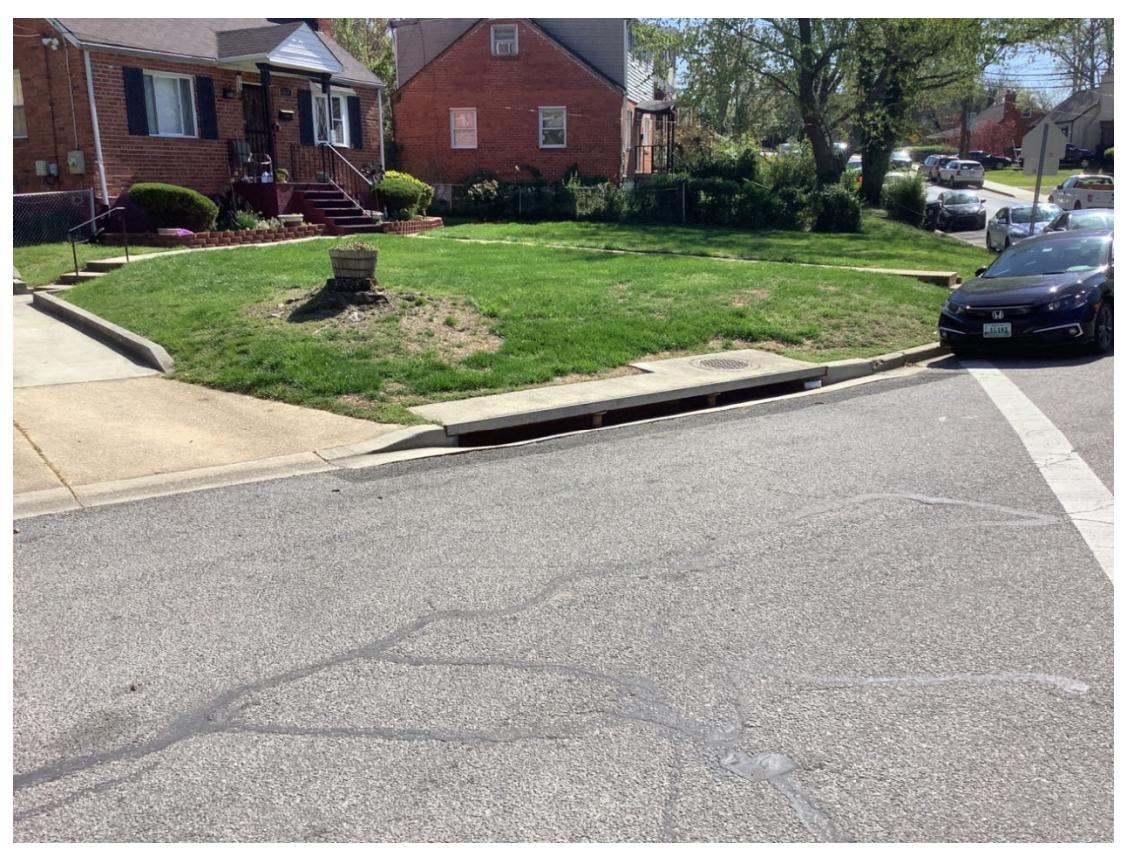
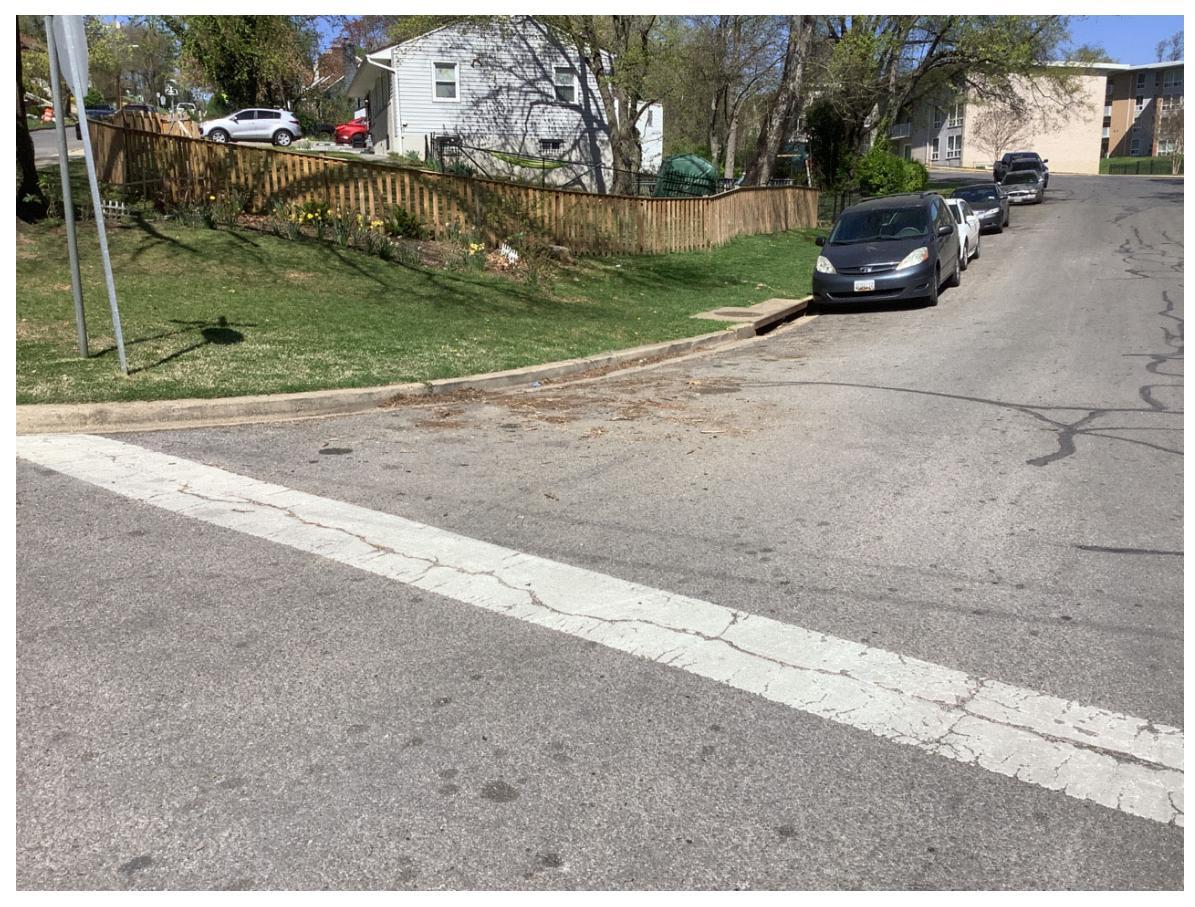
Photo 19. Inlet on Eastern Side of Sullivan Drive at Intersection of Kilmer Street, Outfall 1 - Area D
