6301 KILMER STREET,
CHEVERLY, MD
SITE & BUILDING USE
ASSESSMENT STUDY

Table of Contents

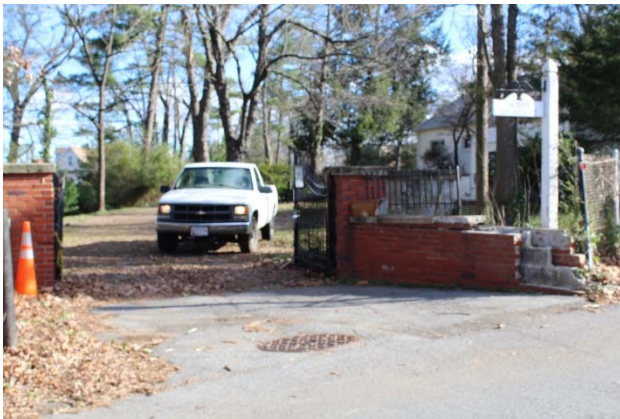
The entry gate will need to be re-hinged to either the existing brick flanking accent walls or new structures. If the existing flanking brick walls are to stay then they will need to be repaired since there is missing brick veneer, missing coping and missing wrought iron guard rail.

Photo 1- Damages to entry wall

Regardless of how the property is developed the aspect of wrought iron gates and flanking stone walls give entry an illusion of something appealing on the other side. If a structure(s) is to be utilized in the new development then a brick veneer would be recommended. If the site is to be used for more natural use, i.e. nature center or dog park, then a more vernacular stone veneer should be applied.

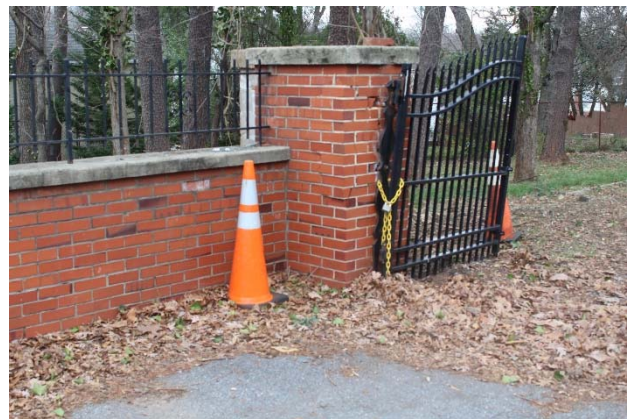
Wrought iron, double swinging gates with flanking brick wing walls entrance, which are in need of repair.

Photo 2- Unhinged gate

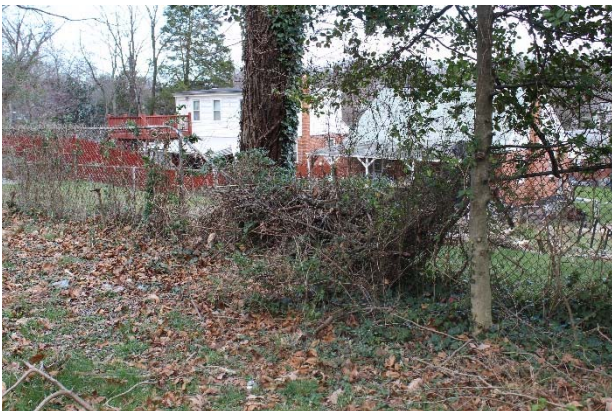
Photo 3- Damages to fencing. Similar damages elsewhere.

Sections of the perimeter property fencing will need to be repaired, regardless of the development of the property. If the property is developed with the need of security or containment, i.e. Dog Park, then a new higher fence will need to be installed.

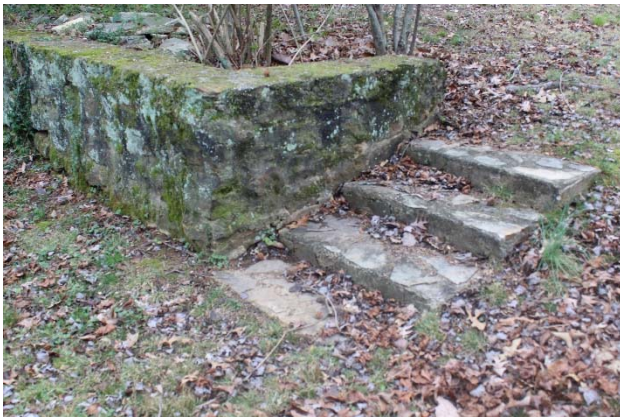
An approximately 3' high x 28 lin. ft., stone retaining wall with stone steps is off of the residential garage. Steps in need of repair.

Photo 4- Retaining wall next to garage w/ steps

Code & safety issue: Commercial use spaces require that any retaining wall greater than 30" above ground level, i.e. the retaining beside the garage and the front entry patio, must have a guard rail. 2015 IBC, Sec 105, 1015.2.

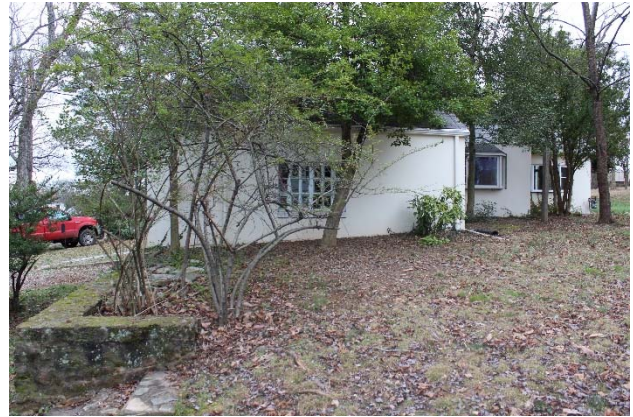
Photo 5- Retaining wall next to garage w/ steps. Side view

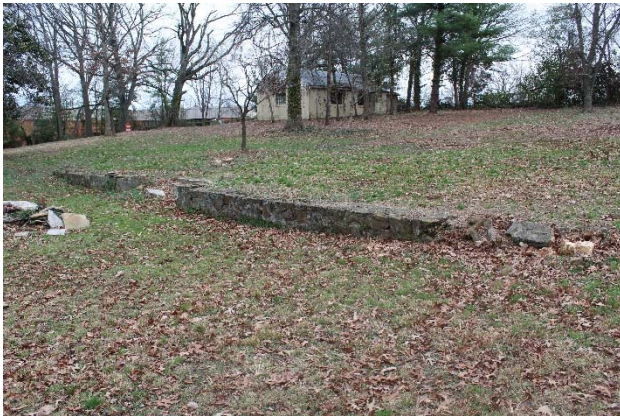
Photo 6- Damaged, rear landscape retaining wall

Front, stone retaining wall abutting the garage and the one on the rear of the landscape actually give the site a nice vernacular appeal. Depending on the development of the property may not be necessary. The front retaining wall is in good to fair condition, however the rear retaining wall behind the man-made pond is in poor condition and should be removed, or at least repaired to its original appearance, which would actually a nice feature. The terrain can be graded to correct the slope, if it's removed.

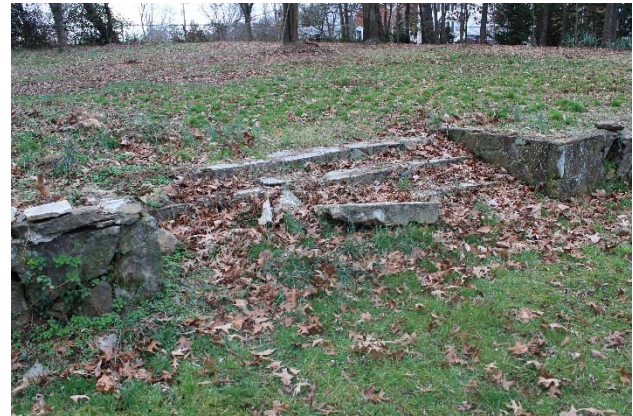
Photo 7- Damaged steps of rear landscape retaining wall

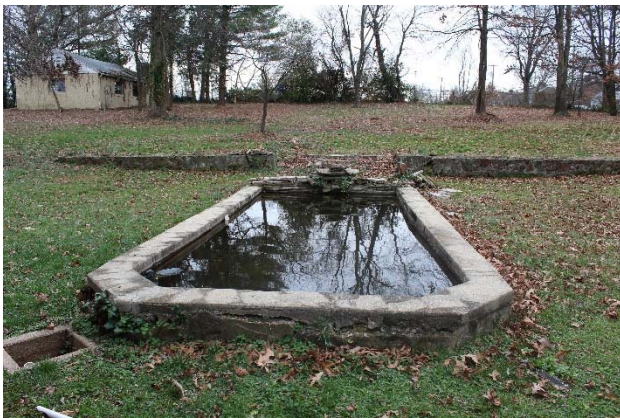
Photo 8- Pond w/ filtering control inset on left. Pointing needed

The pond is actually a nice feature on the site, which becomes a draw. If, it is to stay for any designated development, it will need repair of cracks, coping stone and a new pump system with skimmers. If it stays as a standing pond it will be a draw for mosquitos during warm weather and not so appealing. Functional lily pod pond with a proper filtering system would be recommended.

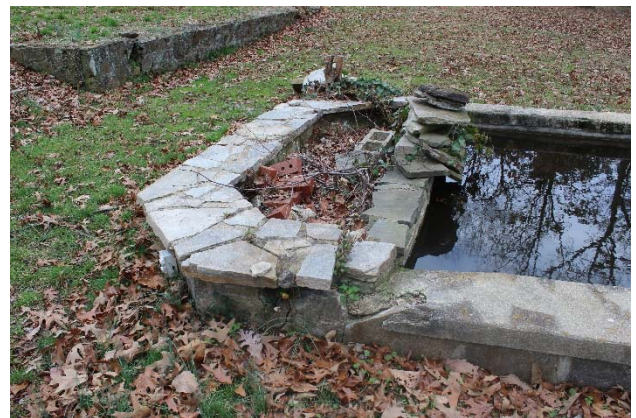
Photo 9- Damages to pond

In addition to the aforementioned, the existing open water source onsite, the pond, is an insurance and safety issue. Insurance companies view any standing “pool” of greater than 12” deep, sometimes less, to be a drowning hazard and a violation of most policies, if it is not fenced off. It is highly recommended that the existing pond be drained or directly fenced off to a height of 4’. It’s also an IBC code violation.

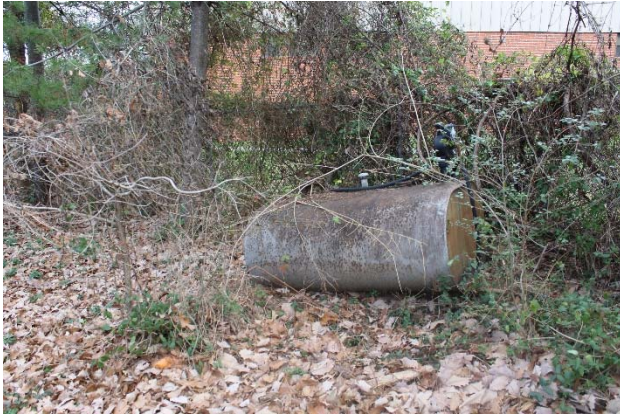
Photo 10- Empty oil tank & wild shrubbery

The property has debris along the south and east perimeters, which need to be discarded. The wild shrubbery should be cleared and prepped for landscaping.

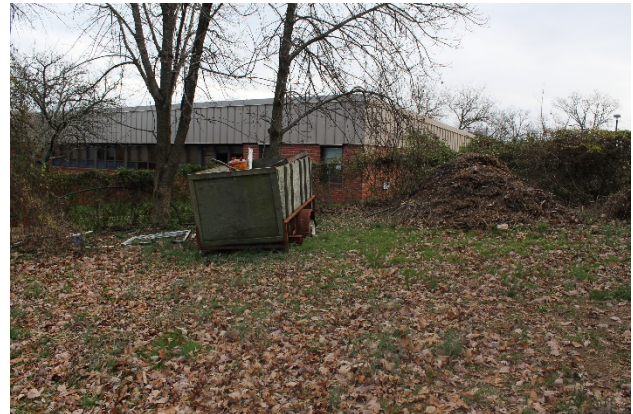
Photo 11- Hauling cart, mulching piles & shrubbery

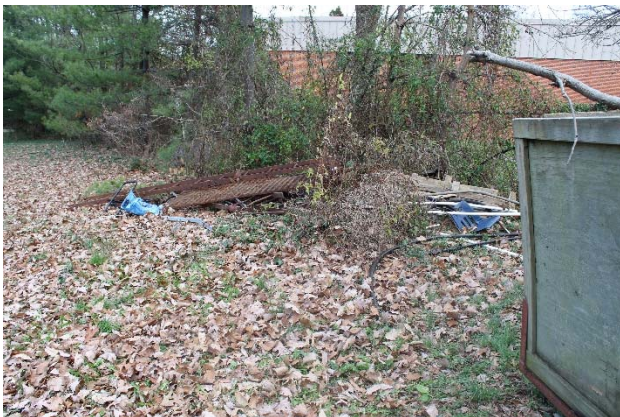
Photo 12- Metal scrape & misc. debris

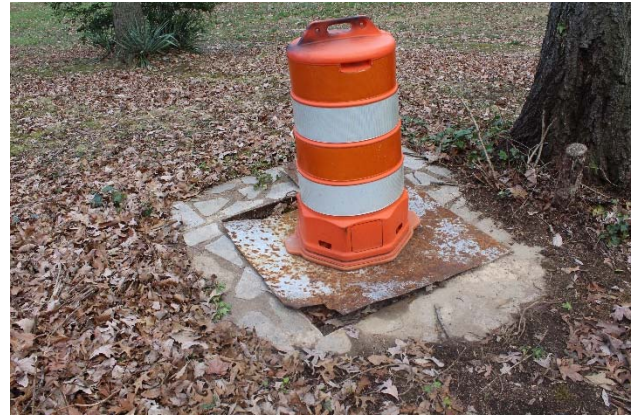
Photo 13- Unsecured storm drain access needs to be addressed

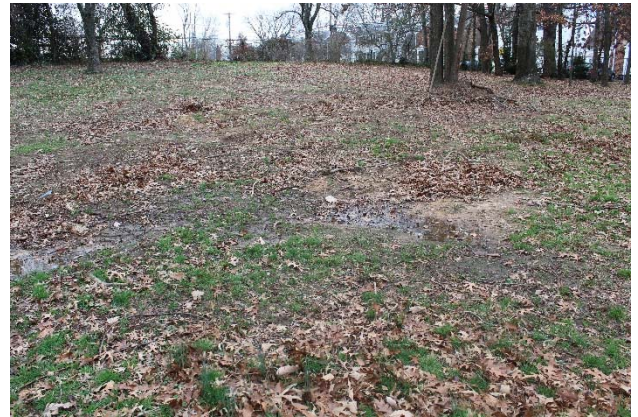
Photo 15- Natural sloped landscape, center of rear property. Minor erosion.

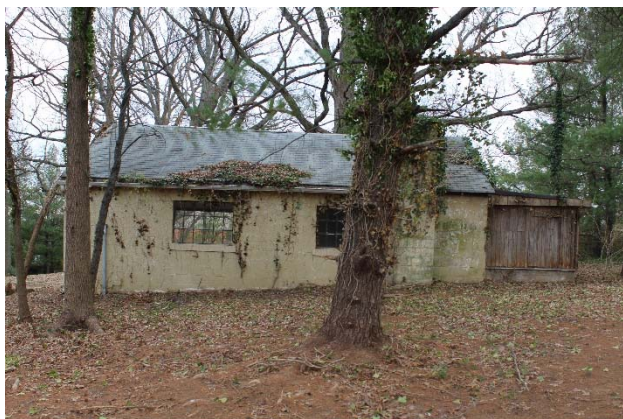
Photo 18- West side of storage garage. Pointing required. Rear wooded shed should be demoed

Refer to “as-built” plans developed for this structure, on page 3. Unless the Town of Cheverly has a need for off-site storage, this structure is useless and should be demoed. At a minimum the wooden lean-to shed on its rear should be demolished. If a covered picnic pavilion is desired, similar to the one at Town Community Park, or outdoor reading or learning pavilion, then the slab foundation can be utilized along with the footings (structurally verified by engineer). We wouldn't recommend tearing it all out until it is determined as to how the property will be developed.

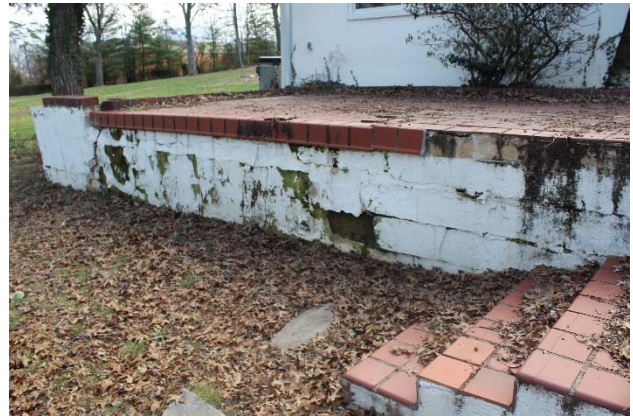
Photo 23- Damages to front patio foundation wall

- a. Front patio will need an HC ramp up to its landing (IBC, Ch 10, Sec. 1012) and another to the entry. It will also need to have guard rails (IBC, Ch 10, Sec. 1014 & 1015) installed and the foundation wall structurally repaired (IBC, Ch 19, Sec. 1904).

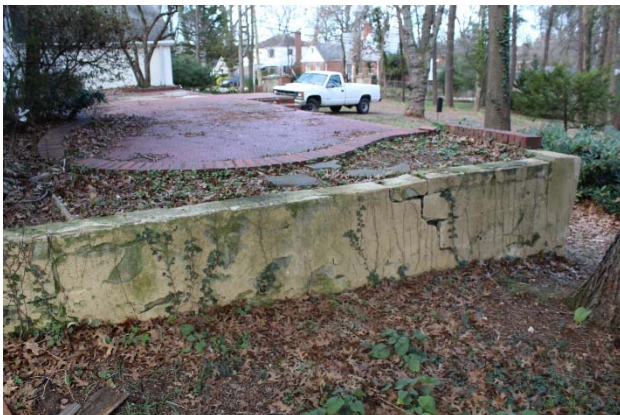
Photo 24- Damages to side of front patio foundation wall

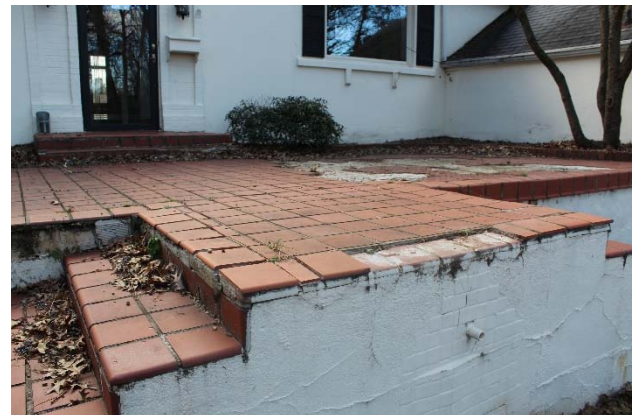
Photo 25- Damages to front patio and steps tile work & slab. Also a code issue since there is not guardrail or handrails.

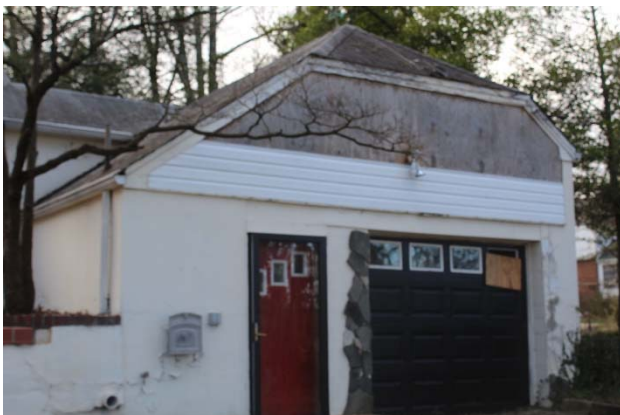
Photo 26- Frontal damages to garage

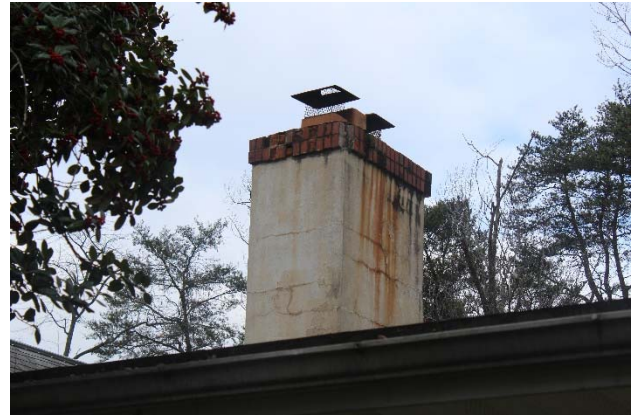
Photo 28- Chimney needs repair of cracks, stains, tilework.

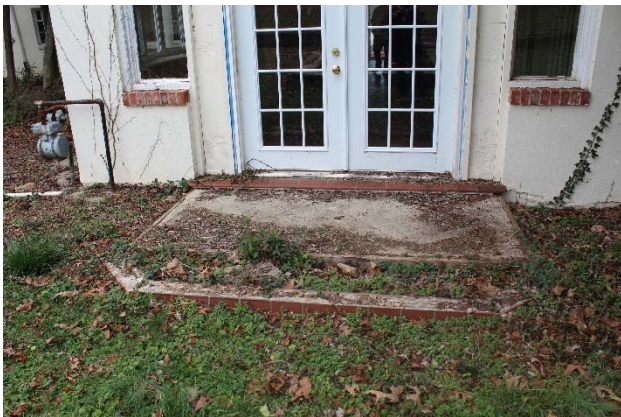
Photo 29- Damages to landing pad from Parlor room.

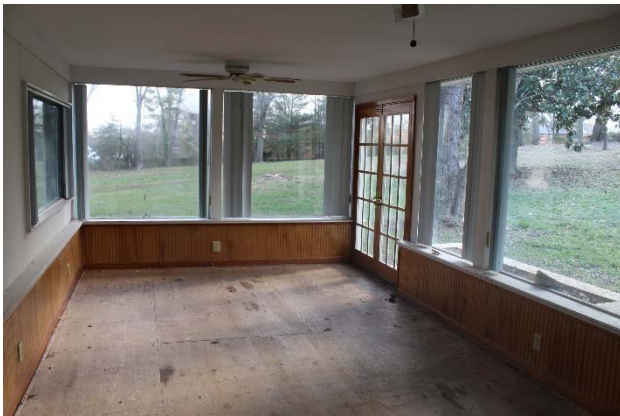
Photo 33- Sunroom. Unfinished flooring.

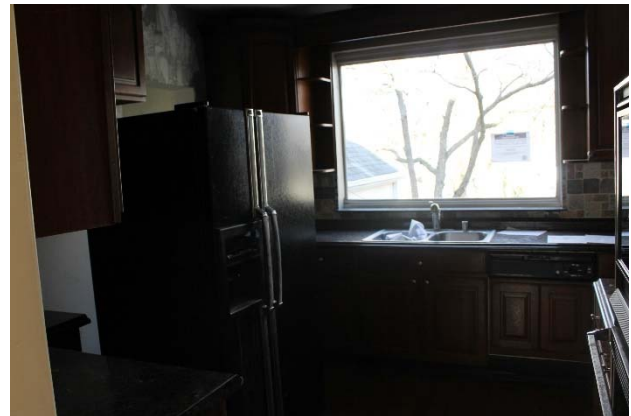
Photo 34- Kitchen. Small and not commercial use compliant

- c. Corridors need to be a minimum of 44" clear, which none are and none of the doors meet commercial code in width or hardware.
- d. Kitchen does not meet commercial kitchen compliance. If the building is renovated as a non-foodservice use, then the existing kitchen can be utilized as a kitchenette.

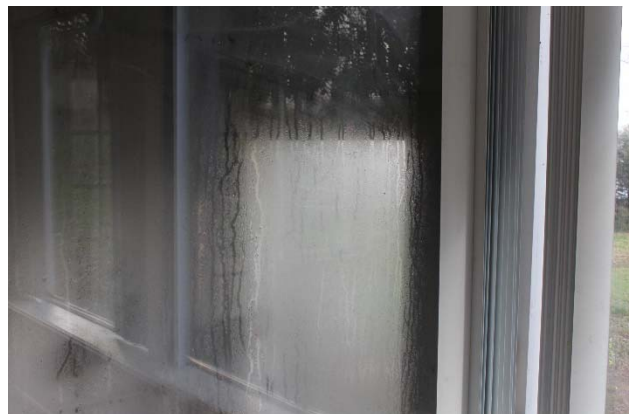
- e. Neither of the two stairways to the Basement are code compliant.
- f. No handicap access to the Basement.
- g. Not all the windows are not energy efficient. Condensation between the panes are evident.

Photo 36- Window condensation on interior Bedrm window

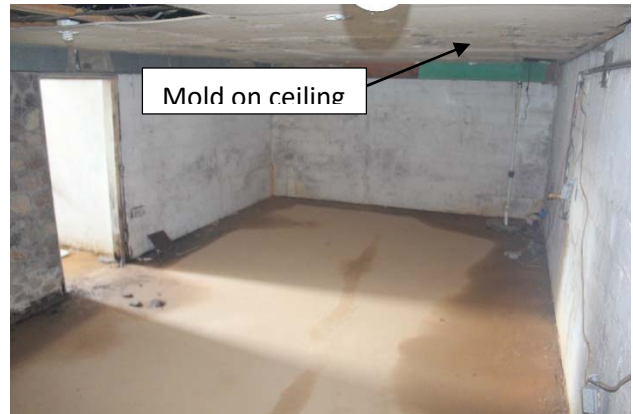
- j. Mold exist in the Basement along the ceiling, walls, and other surfaces.

Photo 38- Basement. Wet slab can be sign of sump pump failure. Mold on ceiling and walls

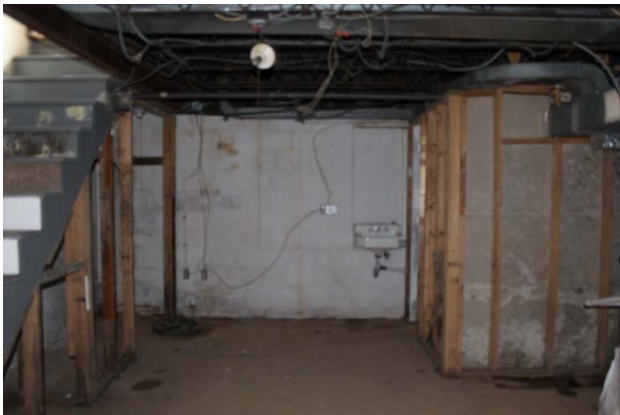
Photo 39- Basement. Mold on walls, wet slab, and non-structurally sound stairs

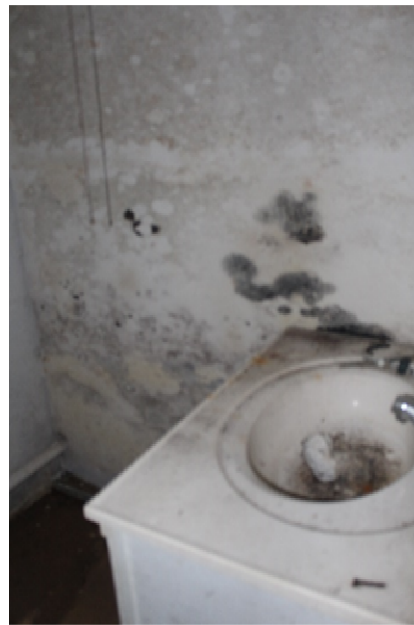
The basement, which is accessed from the interior via a hallway off of the foyer and the exterior via an enclosed stairwell, is unfinished. It has a fireplace and an outdated, poor condition, and non-compliant restroom, along with the furnace and hot water heater.

Photo 40- Moldy restroom

- b. The Bathroom will need to be renovated to meet HC compliance and occupancy load (IBC, Ch 29, Sec 2902). An additional restroom will need to be built, so as to have a Men's and Women's room.

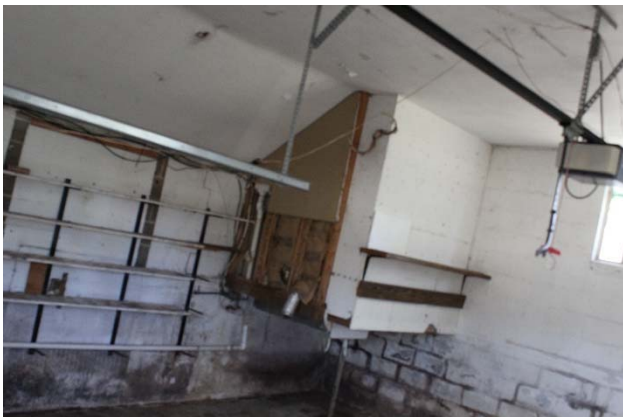
Photo 41- Sample interior view of garage. Wet slab, pointing needed, mudroom/laundry rm extension is not structurally sound. Needs to be removed.

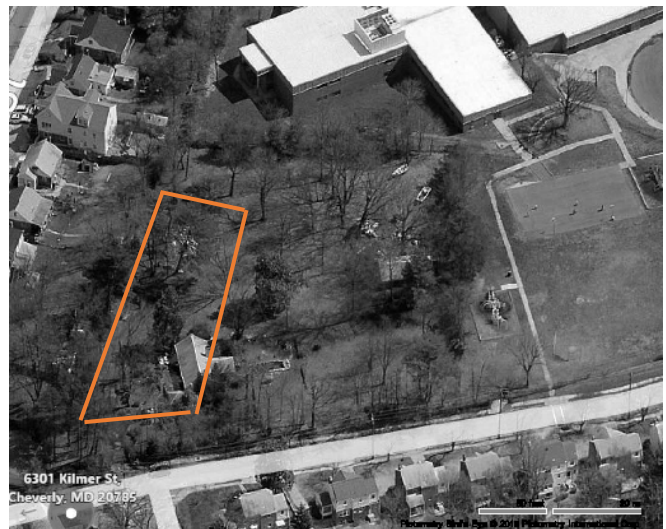
For whatever use of the property it would be best if parking is located on the lower section of the property to allow for greater run-off control. There is no street parking available, so any preference for off the street parking would need to be 90° inset parking within the property line, beyond the walkway clearance.

Photo 43- Recommended parking location within property.
