# The Clean Water Partnership Cheverly Stream Restoration

Presentation to the Cheverly Mayor & Town Council Work Session May 25, 2023

# Cheverly Stream Restoration Presentation May 25, 2023

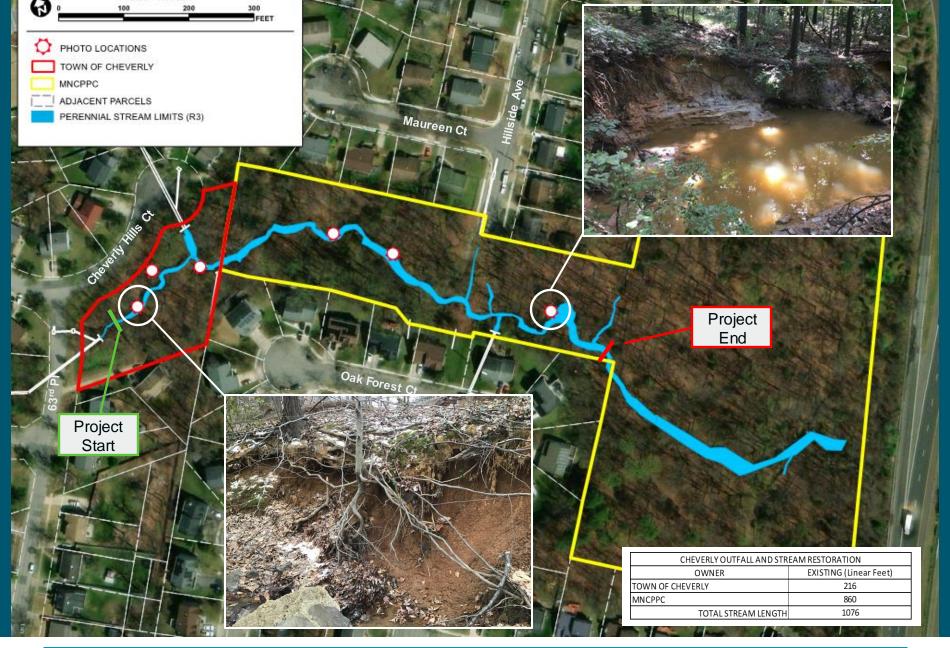
- Stream Stabilization Project near 63<sup>rd</sup> Place & Cheverly Hills Court
- Approximately 1,200 linear feet
- Eliminate Existing Stream Bank Erosion
- Expand Channel/Upland Connectivity and Floodplain Capacity
- Minimize Impacts to Forest Resources
- Invasive Species Removal and Management
- Infrastructure Protection

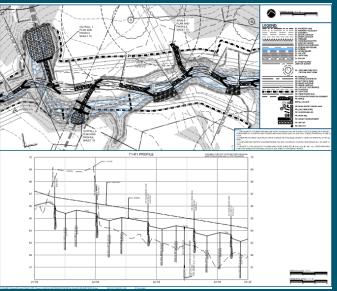
#### Project Design – Main Channel

- Outfall Stabilization
- Channel Realignment
- Floodplain Connection
- Riffle and Grade Control
- Bank Stabilization
- Infrastructure Protection

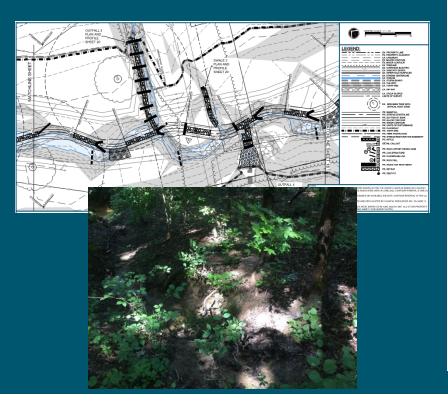
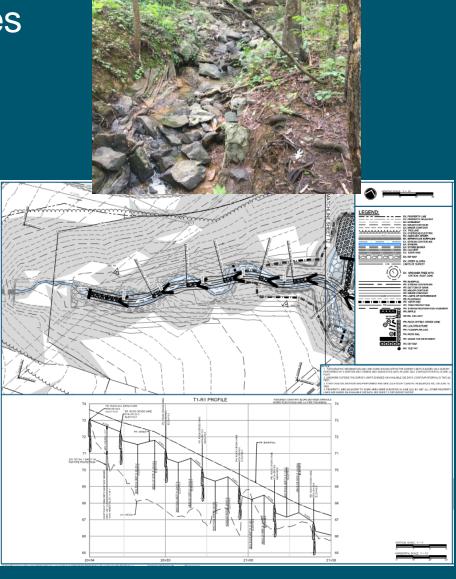
### Project Design – Tributaries

Steep Conveyance

Infrastructure Protection

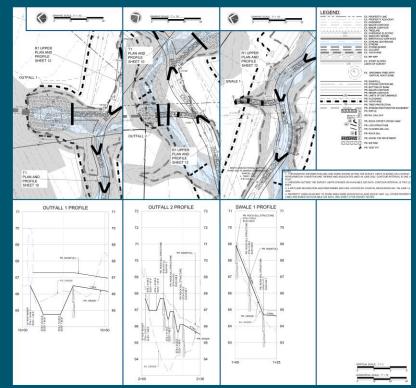
#### Project Design – Outfalls

- Direct Discharge to Channel
- Plunge Pools
- Stormwater Protection
- **Grade Control**

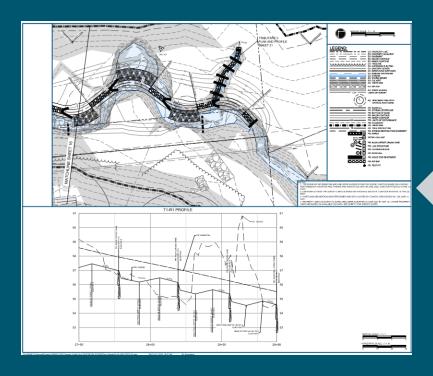
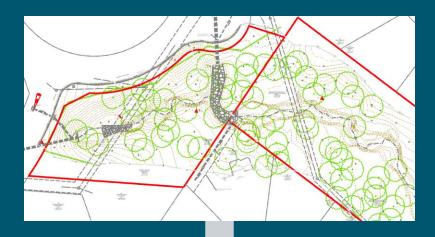
#### Project Design

- Minimize Impacts to Forest Resources
  - Detailed Survey of Existing Trees
  - Design to Decrease Tree Loss

Tree ID	Common Name	Scientific Name	DBH (IN)	Condition	Comments
018	White oak	Quercus alba	38	Fair	Some vines, dead branches
020	White oak	Quercus alba	35	Fair	Vines, dead branches
024	White oak	Quercus alba	37	Poor	Many vines, leaning
128	Tuliptree	Liriodendron tulipifera	33	Fair	Many vines, reduced canopy
138	Northern red oak	Quercus rubra	34	Fair	Few dead branches, undermined
154	White oak	Quercus alba	33.5	Fair	Many vines in canopy.
039	Northern red oak	Quercus rubra	32	Fair	Many vines
147	Sweetgum	Liquidambar styraciflua	31.5	Fair	Vines, reduced canopy
080	Tuliptree	Liriodendron tulipifera	30, 23	Good	Few vines
082	White oak	Quercus alba	30	Good	Few vines
092	Red maple	Acer rubrum	31, 5, 3	Good	
164	Willow oak	Quercus phellos	33, 14	Good	Few broken branches
180	Red maple	Acer rubrum	31	Good	
182	White oak	Quercus alba	32	Fair	Vines, few dead branches
190	White oak	Quercus alba	32	Good	
205	Willow oak	Quercus phellos	33.5	Good	Few dead branches

209	Pin oak	Quercus palustris	32.5	Fair	Dieback, reduced canopy, vines
210	White oak	Quercus alba	30	Fair	Reduced canopy
213	White oak	Quercus alba	37.5	Good	
214	Scarlet oak	Quercus coccinea	38	Fair	Vines, dead branches

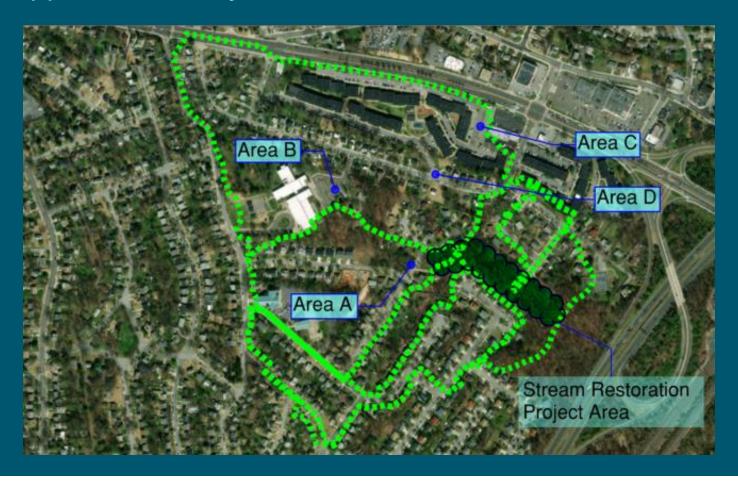
#### Watershed Study

- ESD Upgrades
- Four (4) Areas Currently Identified
